Report of

Preliminary Investigation for Determination of an Area in Need of Redevelopment

Block 3100 Lots 21, and 23 through 43

Prepared For:
Township of Nutley
Essex County, New Jersey
July 2020

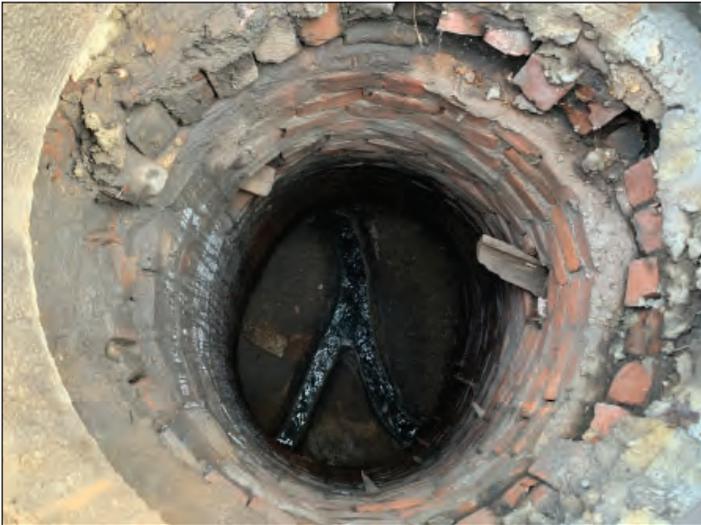
Figure 5: Manhole on West Plaza, with loose bricks, broken wood component, and sediment accumulation.

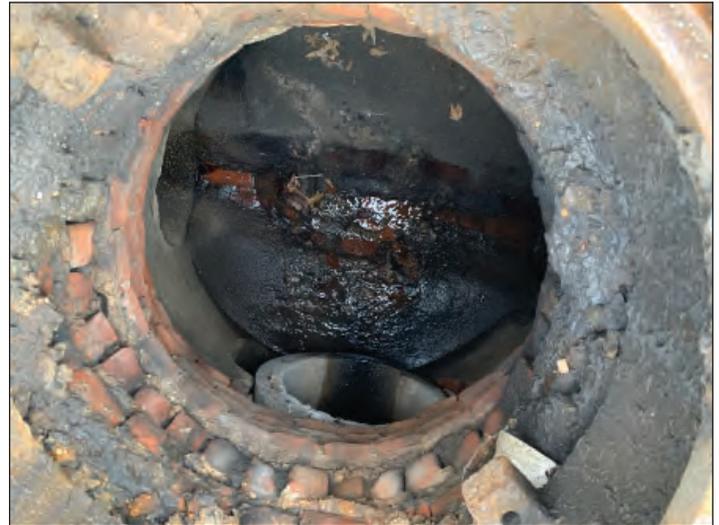
Figure 6: Manhole on West Plaza, with loose bricks, sediment accumulation, and asphalt previously used for repairs.

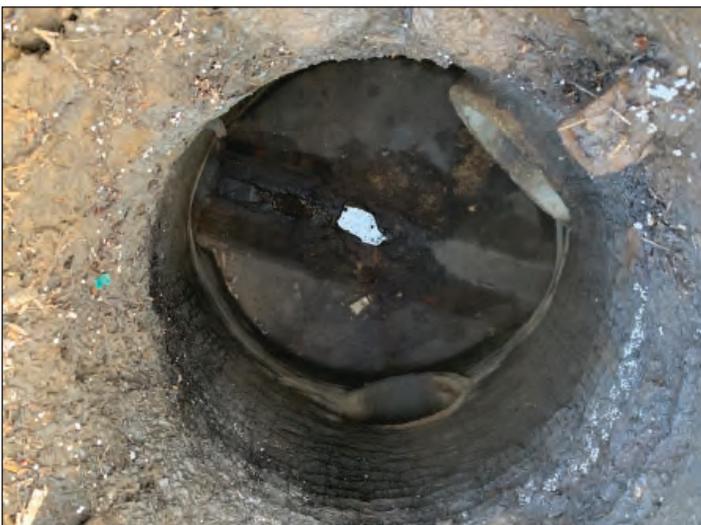
Figure 7: Manhole on Franklin Avenue, with sediment accumulation, and asphalt previously used for repairs.

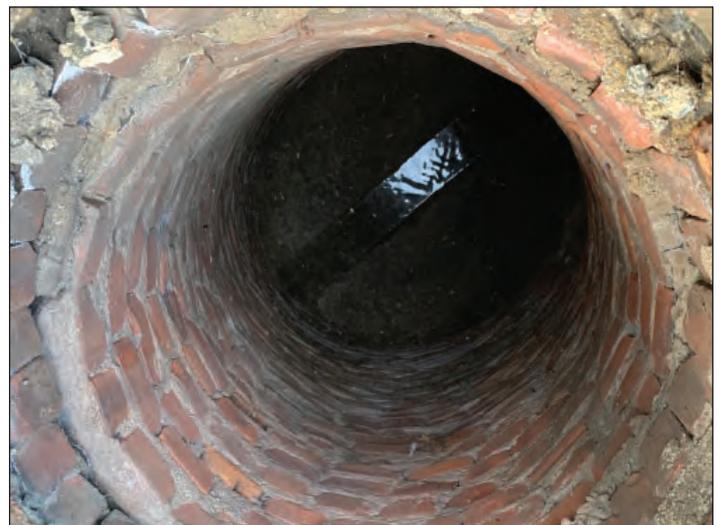
Figure 8: Manhole on West Plaza, with loose bricks and missing mortar.

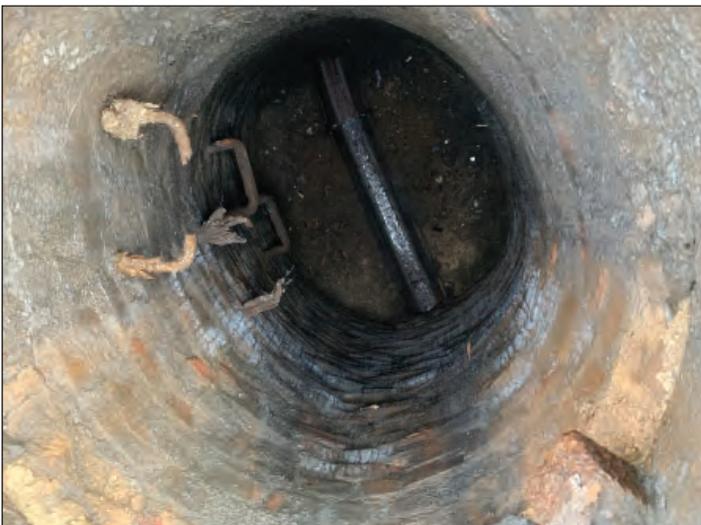
Figure 9: Manhole on Vreeland Avenue, with broken ladder rungs.

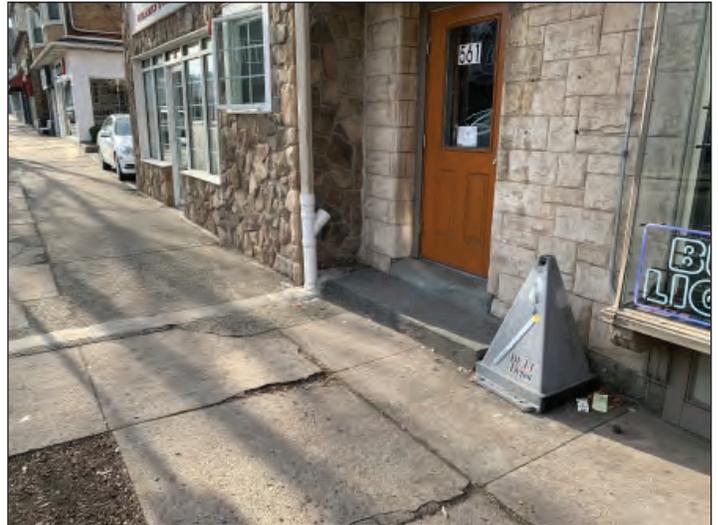
Figure 2: Non-ADA accessible entrance in front of damaged sidewalk blocks.

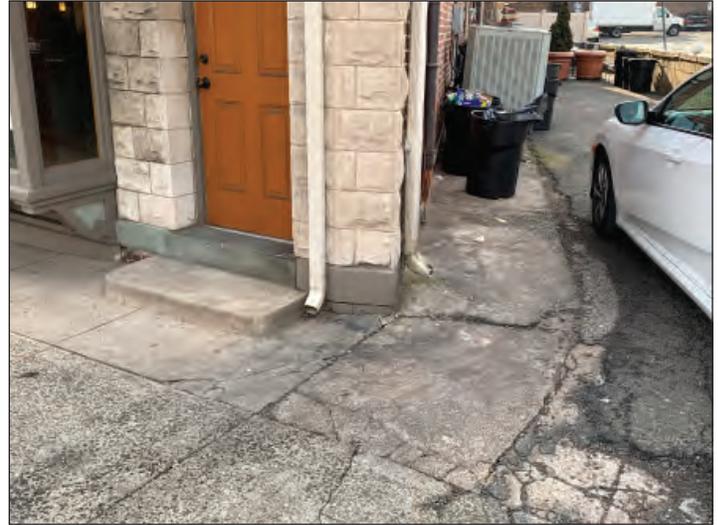
Figure 8: Non-ADA accessible building entrance. Downspouts opening onto deteriorated sidewalk and driveway pavement.

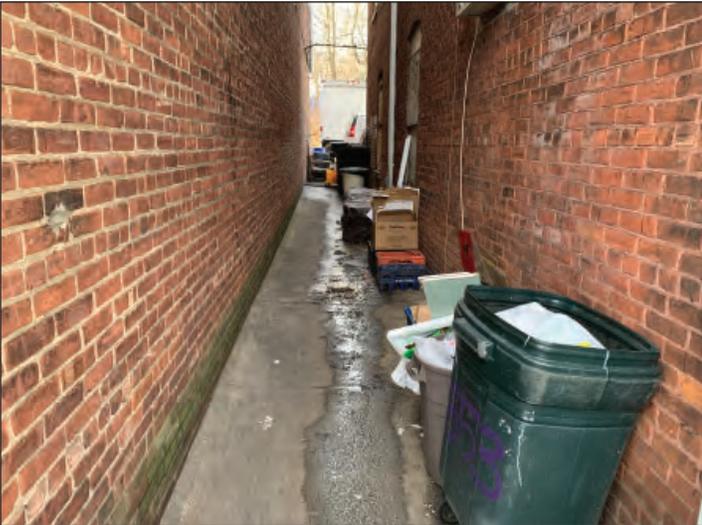
Figure 3: Alley between buildings on Lots 26 and 27, used for trash storage and having standing water due to inadequate drainage.

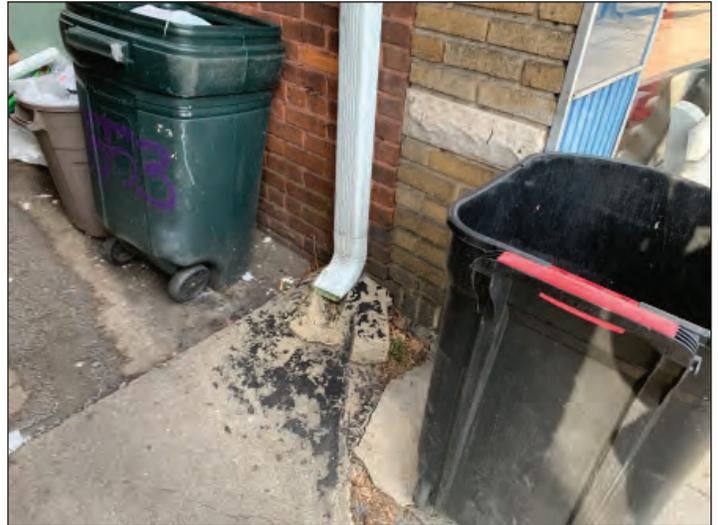
Figure 4: Downspout directed toward sidewalk

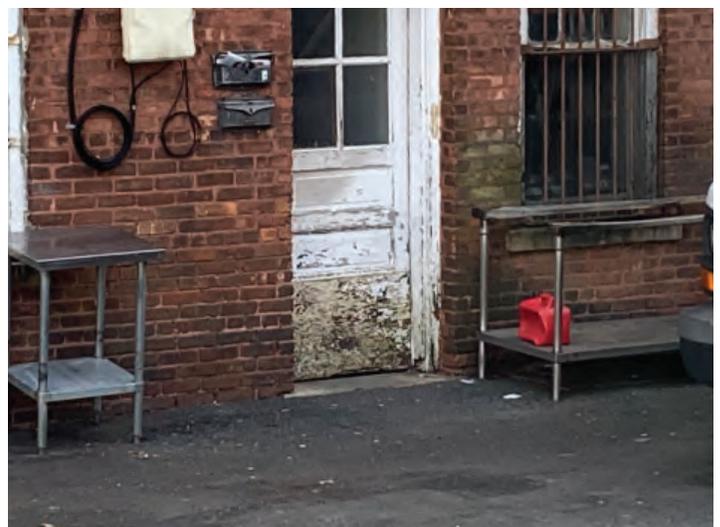
Figure 12: Water damaged rear door at 551/553 Franklin Avenue (Lot 26).

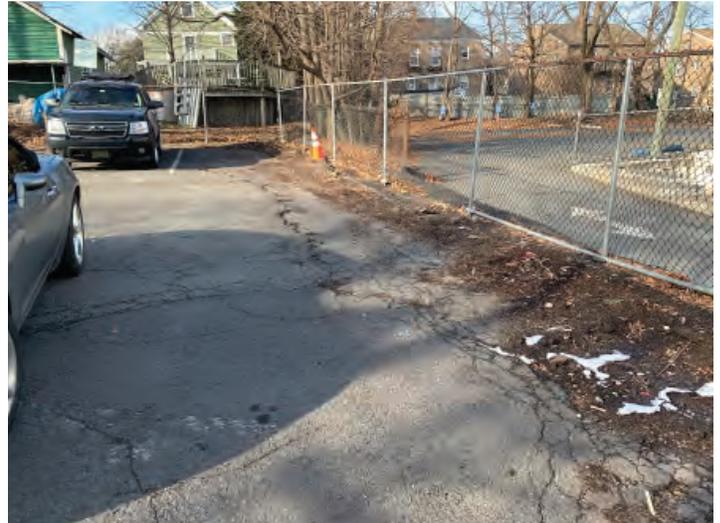
Figure 2: Deteriorated pavement in northwest corner of Lot 28.

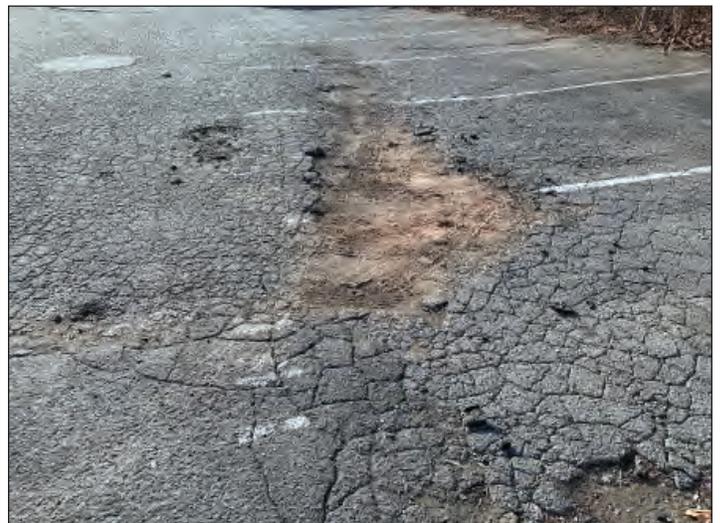
Figure 4: Deteriorated or missing pavement in parking spaces on Lot 28.

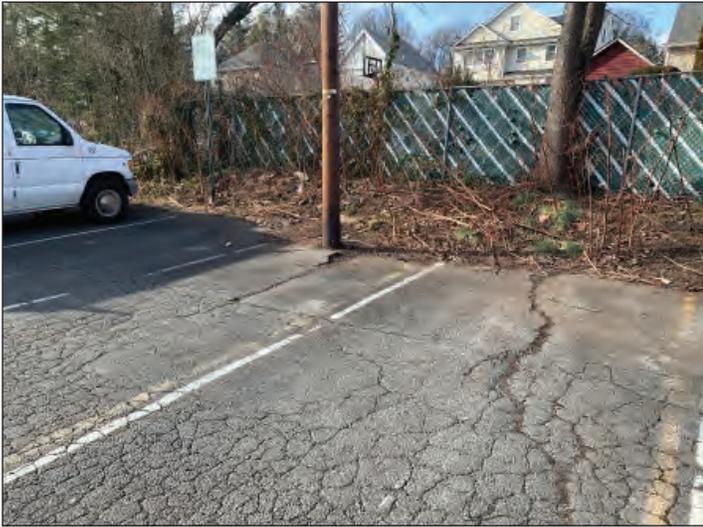
Figure 5: Deteriorated pavement on Lot 28, and utility pole at front end of a delineated parking space

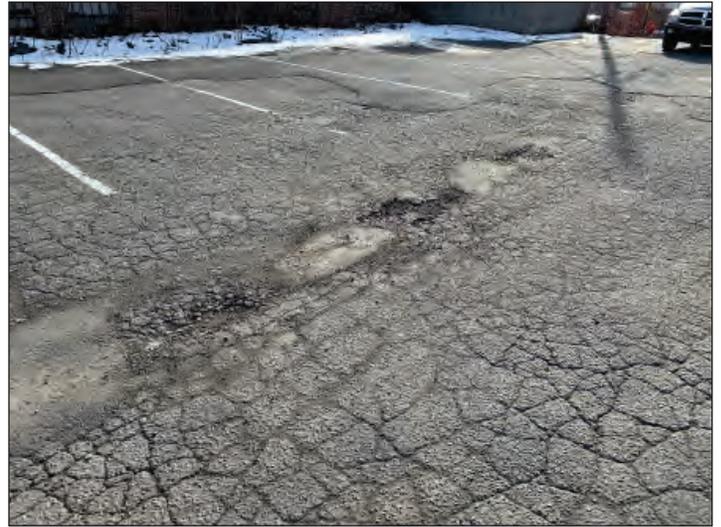
Figure 6: Deteriorated pavement in access aisle on Lot 28

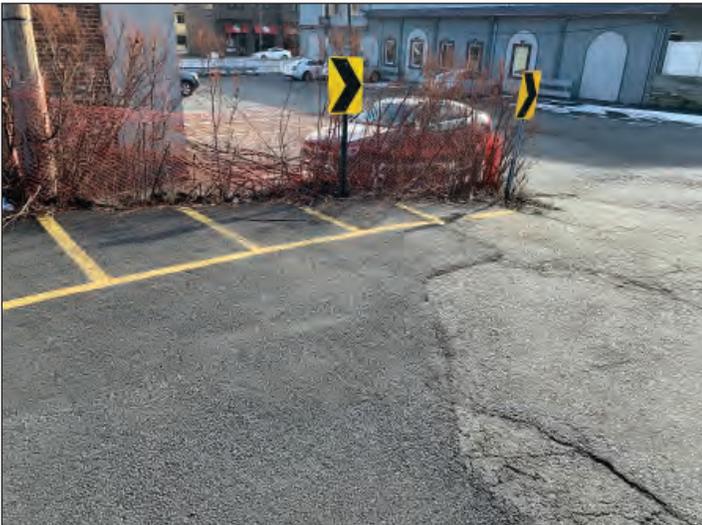
Figure 7: Grade change between Lot 28 and 29 without protective barrier.

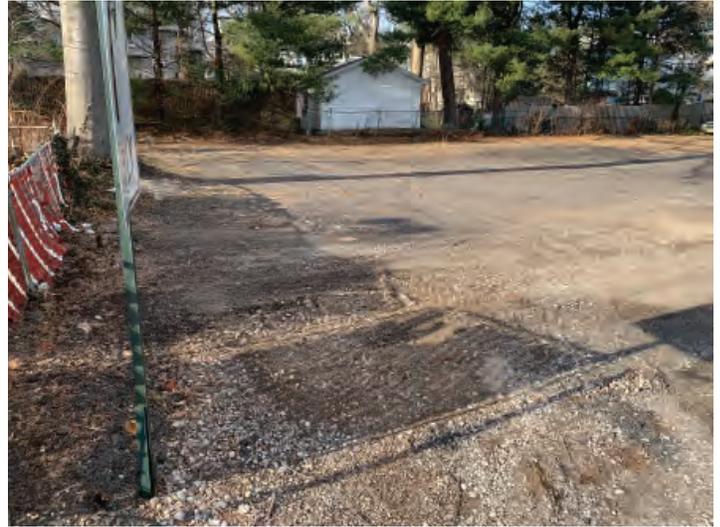
Figure 12: Deteriorated pavement in parking area on southwest corner of Lot 30.

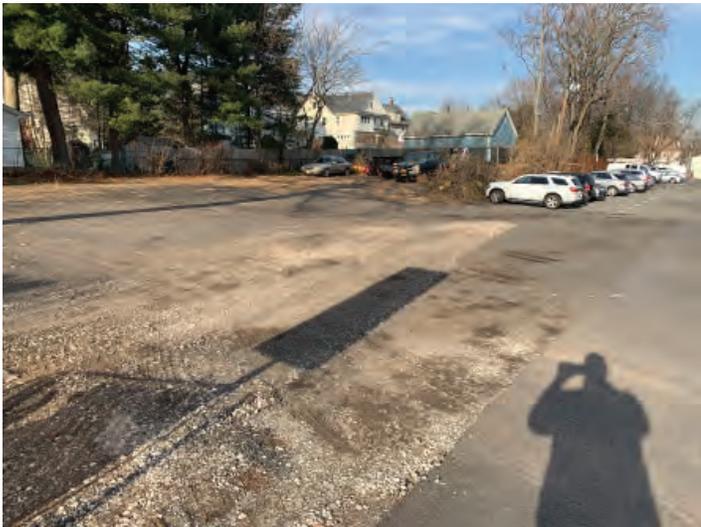
Figure 13: Deteriorated pavement in southwest corner of Lot 30.

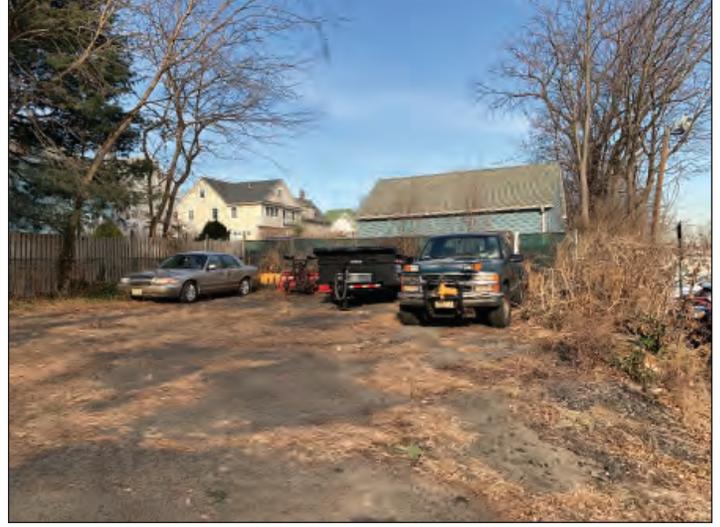
Figure 14: Deteriorated, overgrown parking area at southwest corner of Lot 30, with grade change to circulation aisle (right).

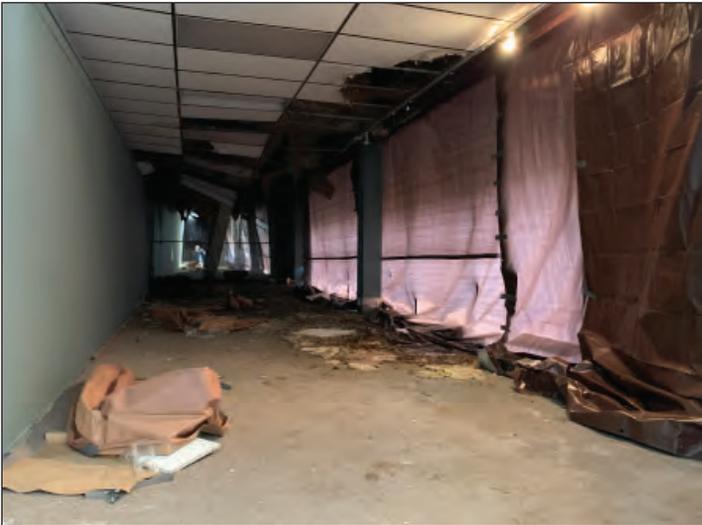
Figure 3: Section of interior with collapsing ceiling, debris, and water damage.

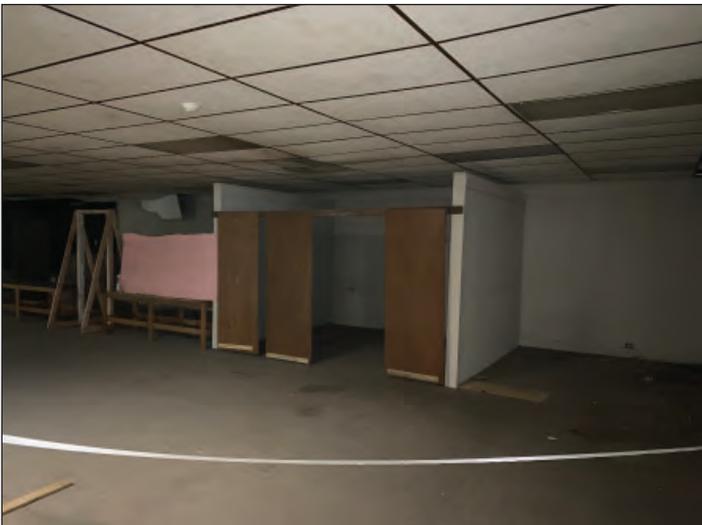
Figure 5: Vacant showroom. Visible water staining on ceiling tiles.

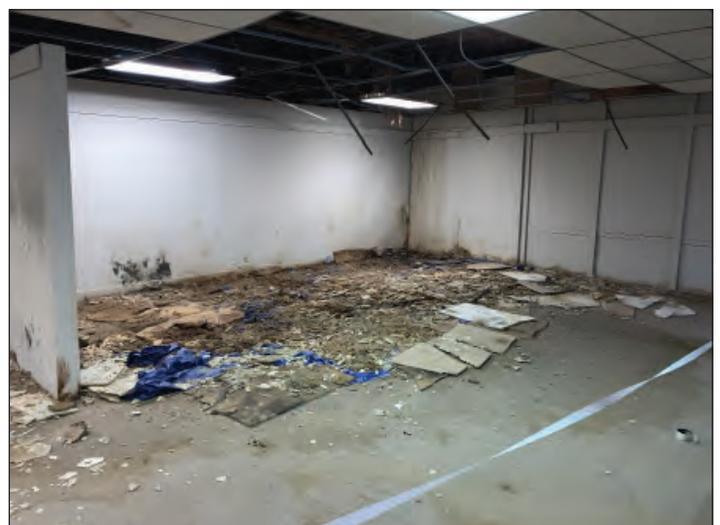
Figure 6: Debris and water damage from collapsed roof/ceiling

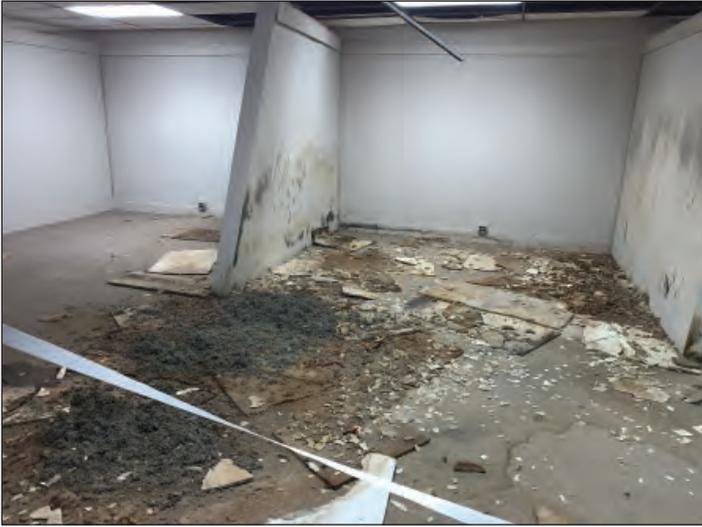
Figure 7: Debris and water damage from collapsed roof/ceiling.

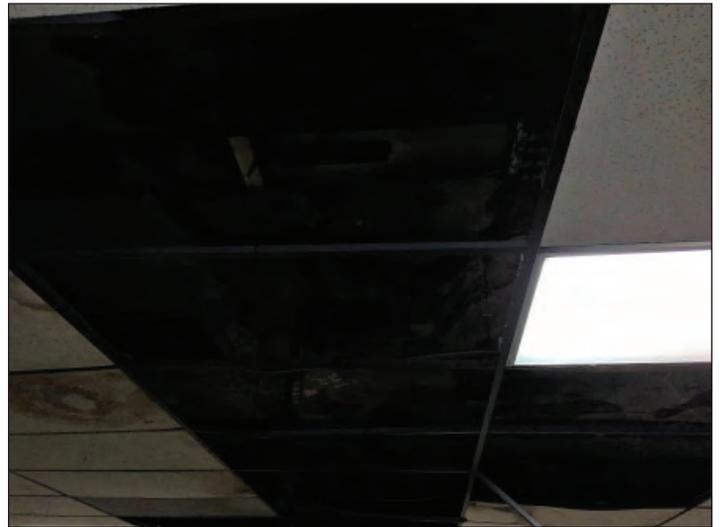
Figure 8: Failed ceiling and roof.

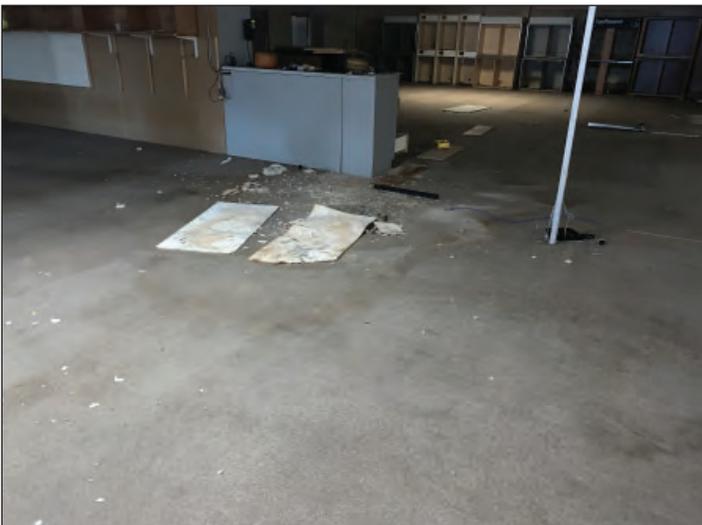
Figure 9: Debris from fallen, water damaged ceiling panels.

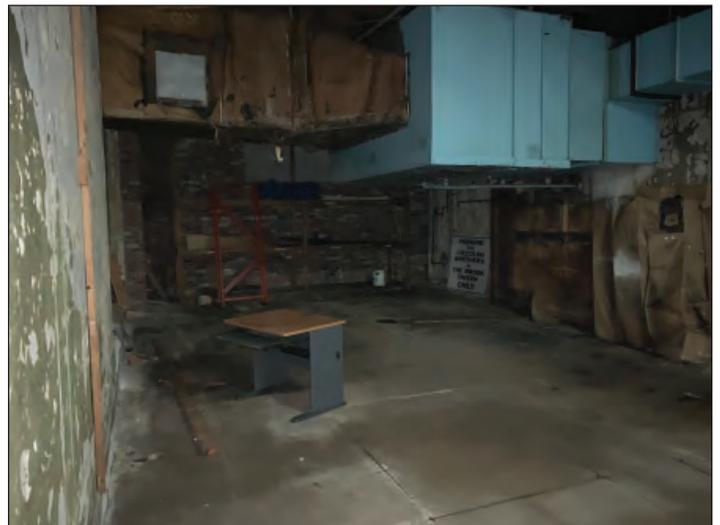
Figure 10: Vacant area at rear of store with damp floor.

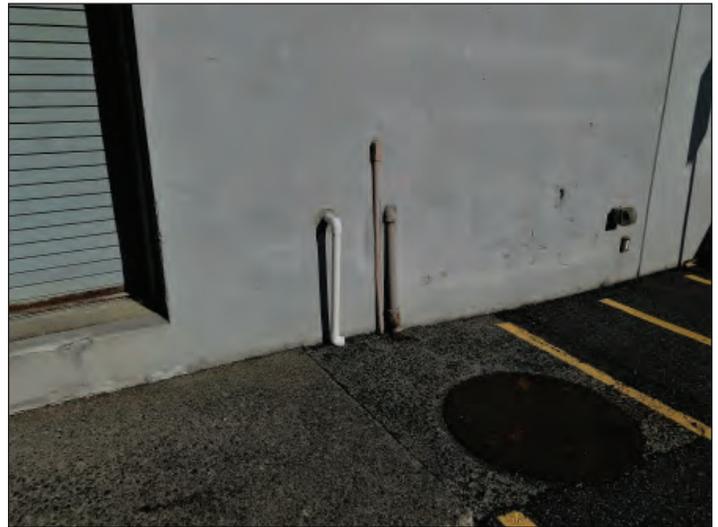
Figure 14: Wall damage near loading door on Lot 30.

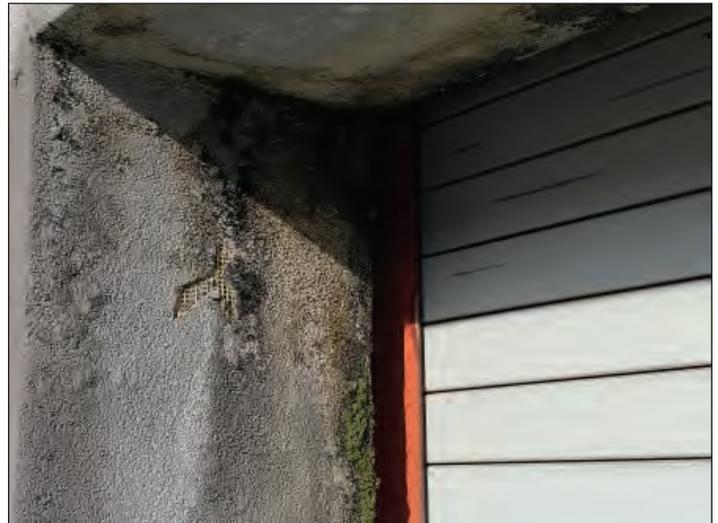
Figure 16: Wall damage near loading door.

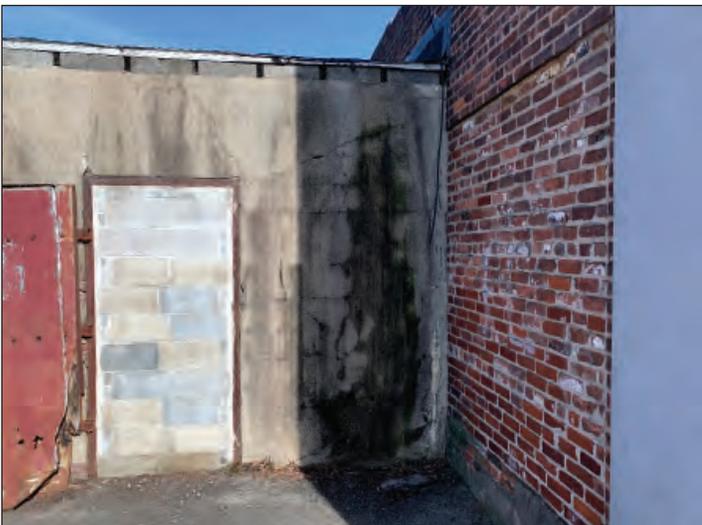
Figure 17: Wall damage with water staining on rear addition to building. Door opening shut with bricks, and old door loosely attached.

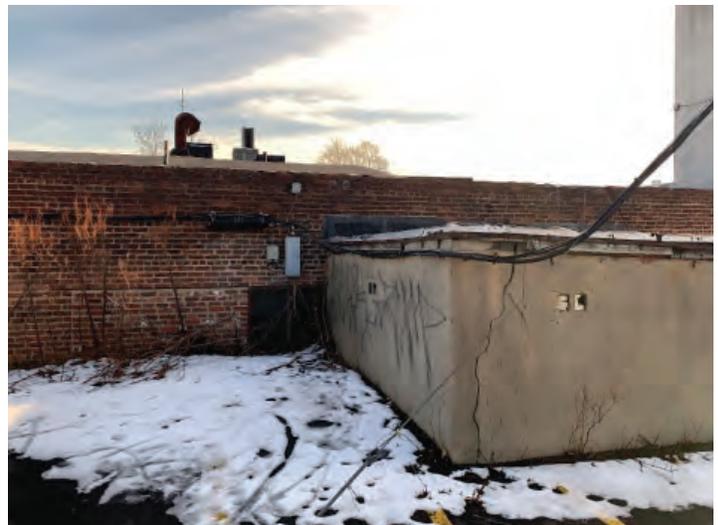
Figure 18: Deteriorated addition at rear of building.

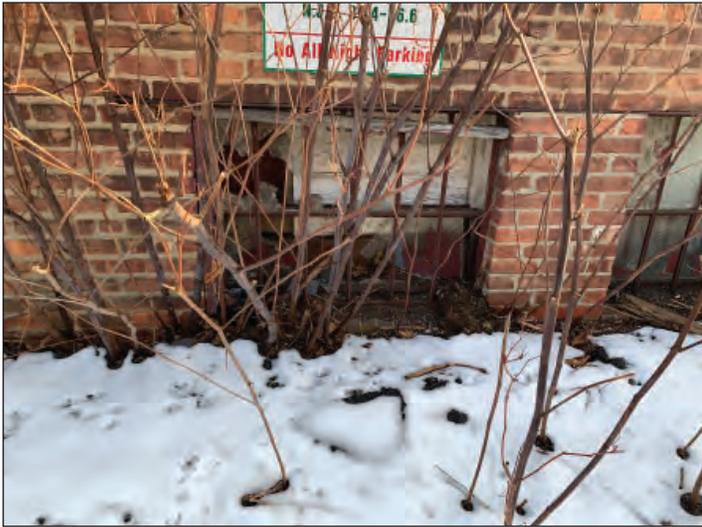
Figure 19: Broken windows and deteriorated brick at back of building.

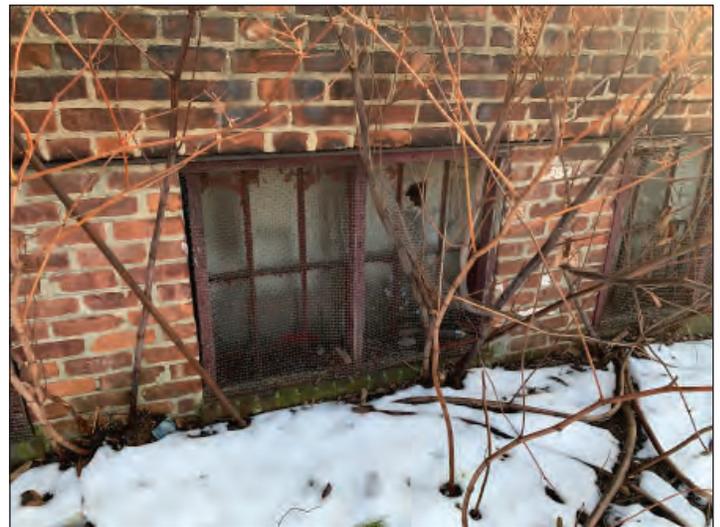
Figure 20: Broken windows and deteriorated brick at back of building.

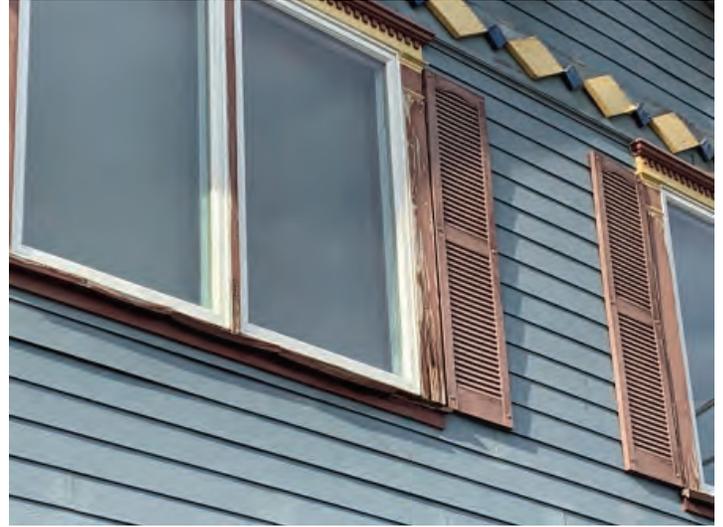
Figure 2: Deteriorated wood window frame.

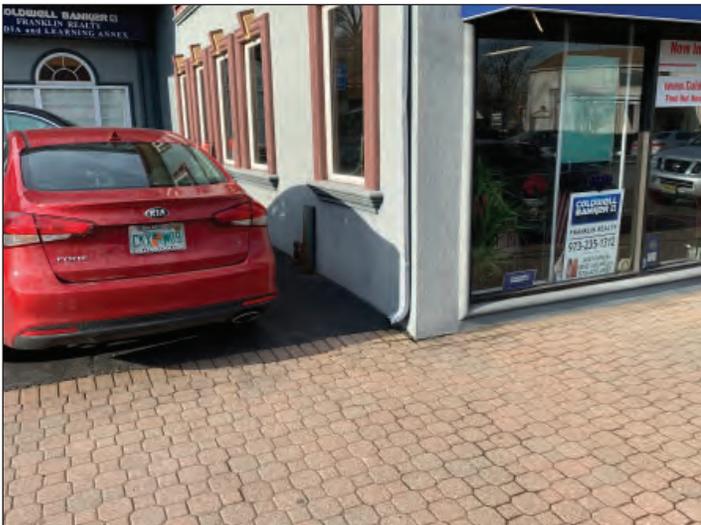
Figure 3: Downspout opening onto sidewalk.

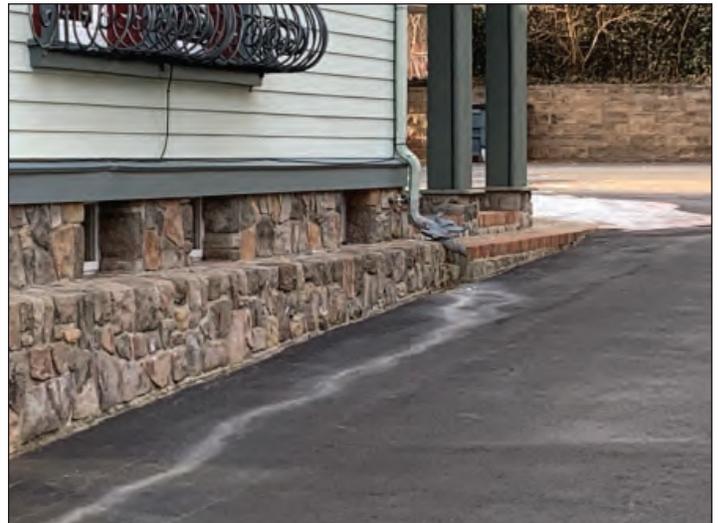
Figure 4: Ornate downspouts opening onto driveway. Visible water staining emanating from downspout.

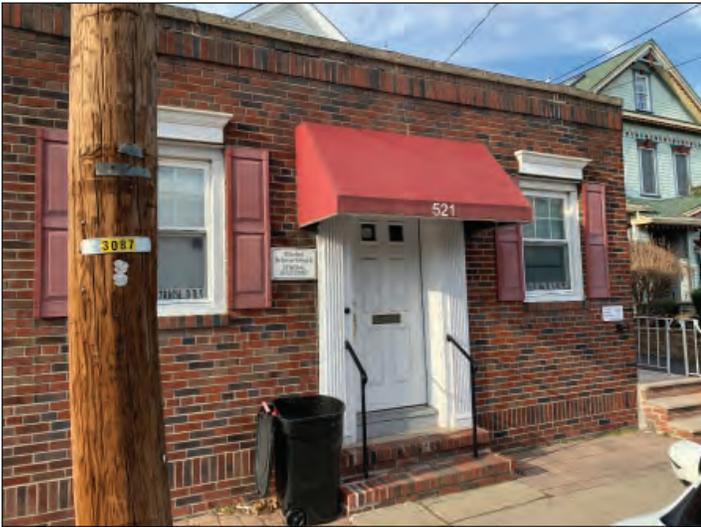
Figure 1: Facade and entrance to front building section. Not accessible to mobility impaired.

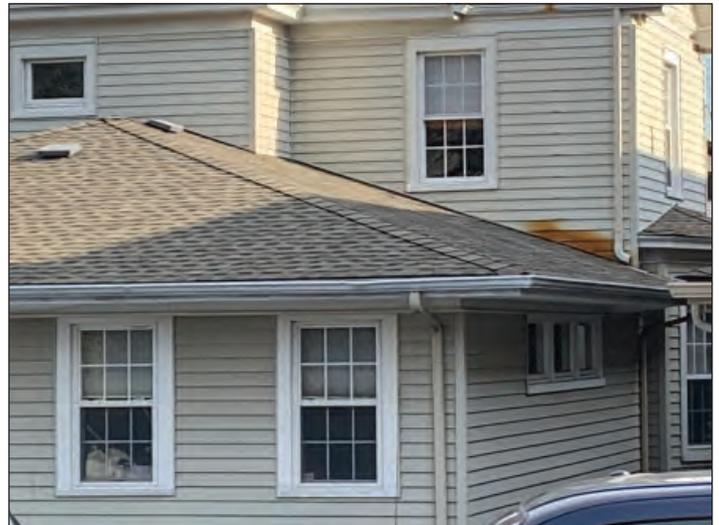
Figure 8: Rust staining on siding at rear of 513 Franklin Avenue (Lot 35).

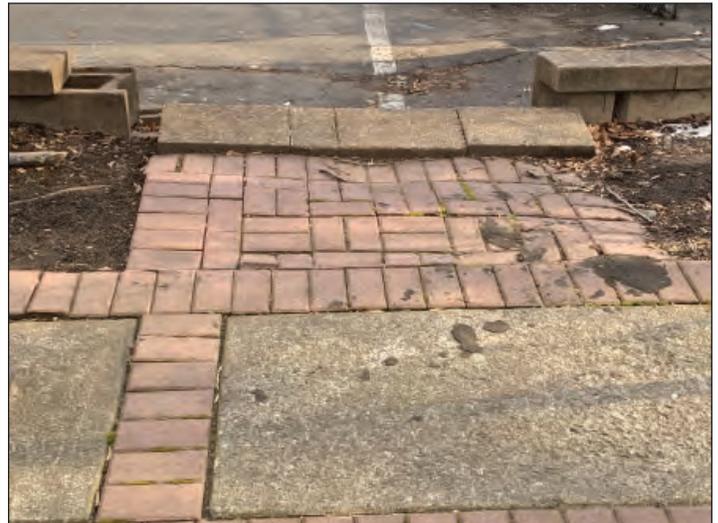
Figure 4: Uneven steps between rear parking area on Lot 38 and parking lot on Lot 39.

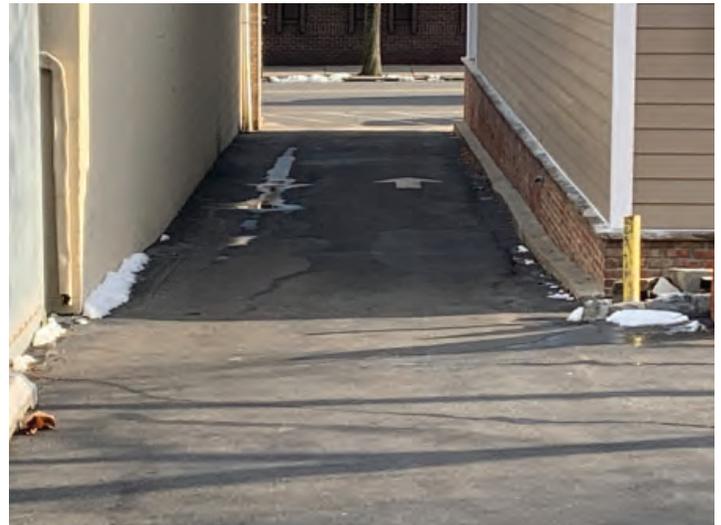
Figure 4: 10-foot wide two-way driveway at north side of lot.

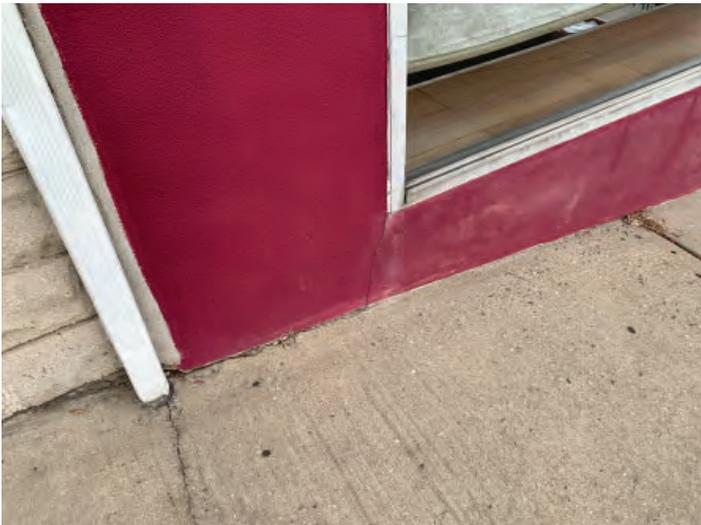
Figure 3: Cracking building wall on Vreeland Avenue side of building.

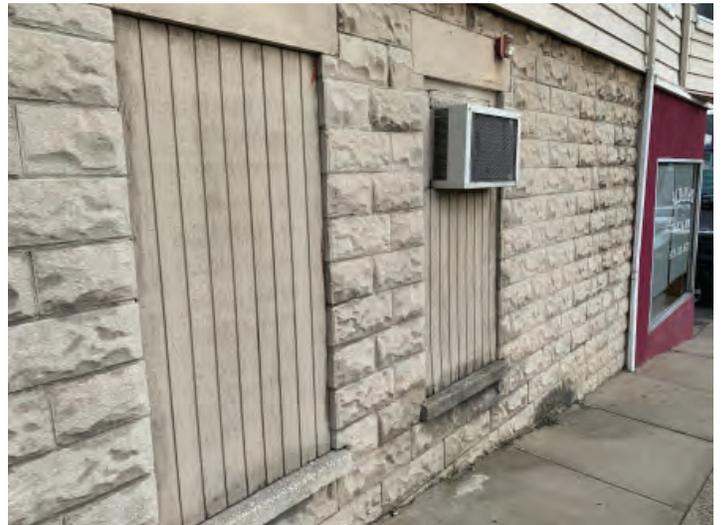
Figure 4: Boarded up windows on Vreeland Avenue side of building.

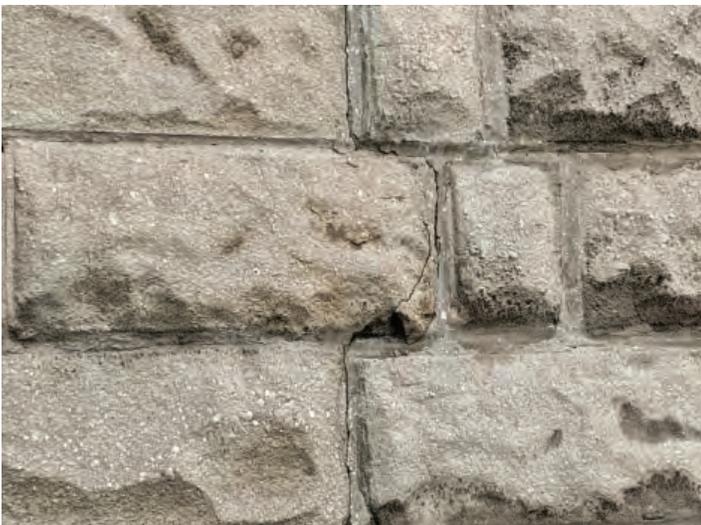
Figure 5: Cracks forming between and on stone facade on Vreeland Avenue side of building.

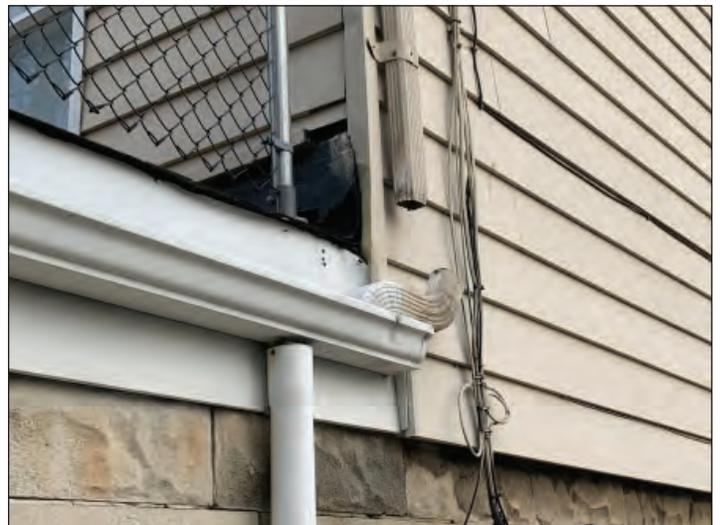
Figure 6: Disconnected downspout pipes at rear of building.

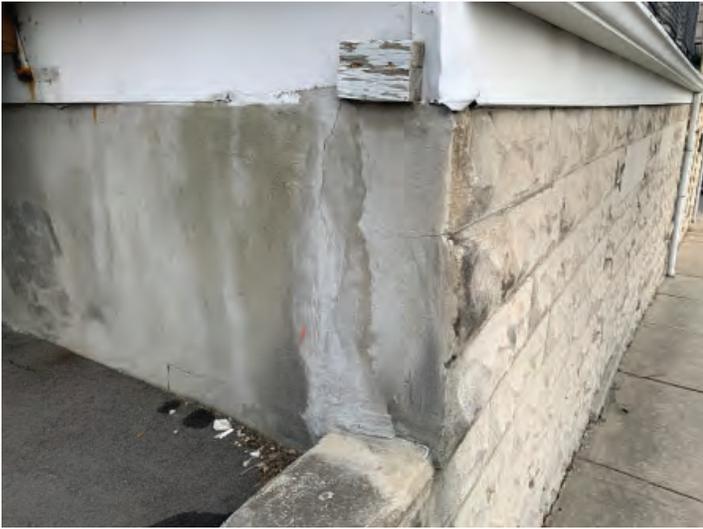
Figure 7: Warped, patched-up exterior wall with water staining at rear building wall.

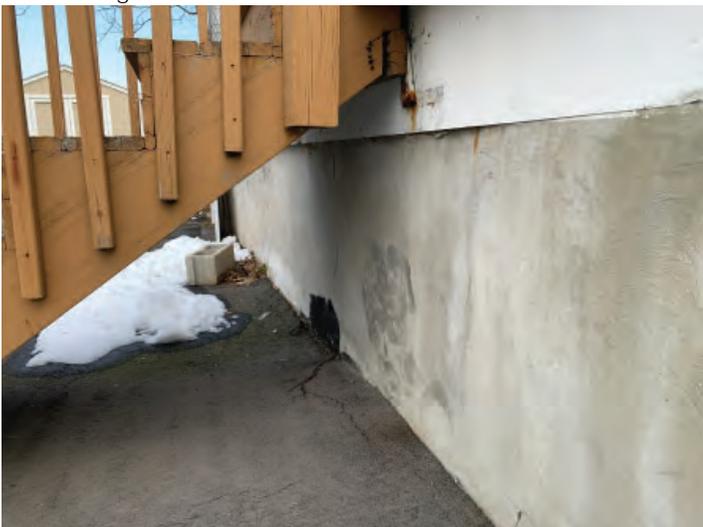
Figure 9: Warped and cracked pavement beneath rear stairs.

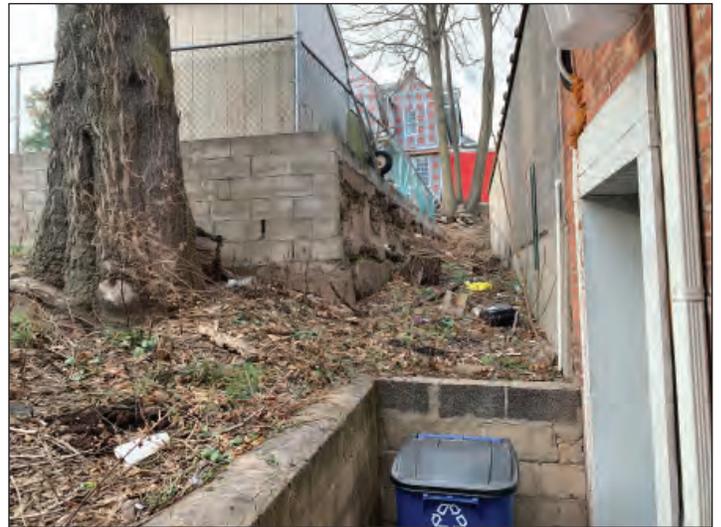
While DMR did not have enough access to the site to diagnose the ongoing causes of damage to the building and retaining wall, it is possible that complete correction of these issues would involve costly work to improve drainage on the site and limit the exposure of vital structures to water.

Figure 10: Crumbling retaining wall supporting parking lot at rear Lot 43.
