Report of

Preliminary Investigation for Determination of an Area in Need of Redevelopment

Block 3100 Lots 21, and 23 through 43

Prepared For:
Township of Nutley
Essex County, New Jersey
July 2020

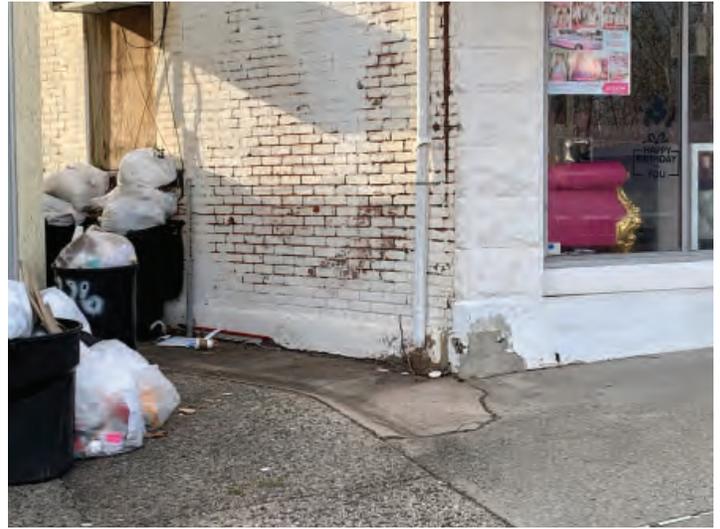
Figure 2: Downspout opening onto sidewalk and public right of way.

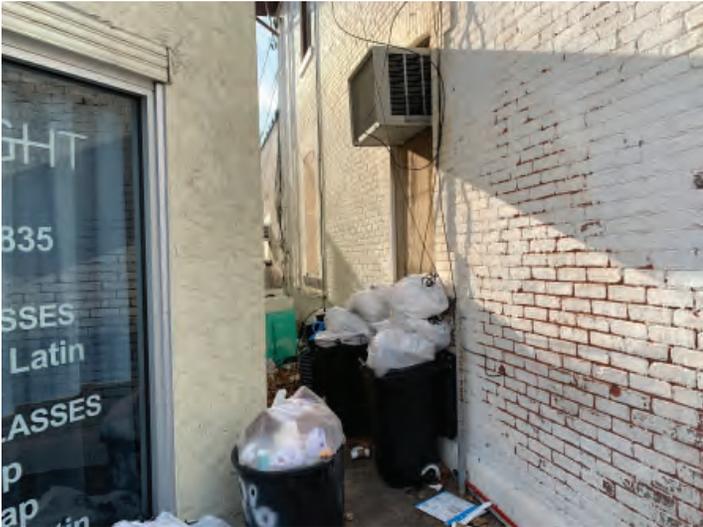
Figure 3: Trash stored in alley, and boarded-up windows on side of building.

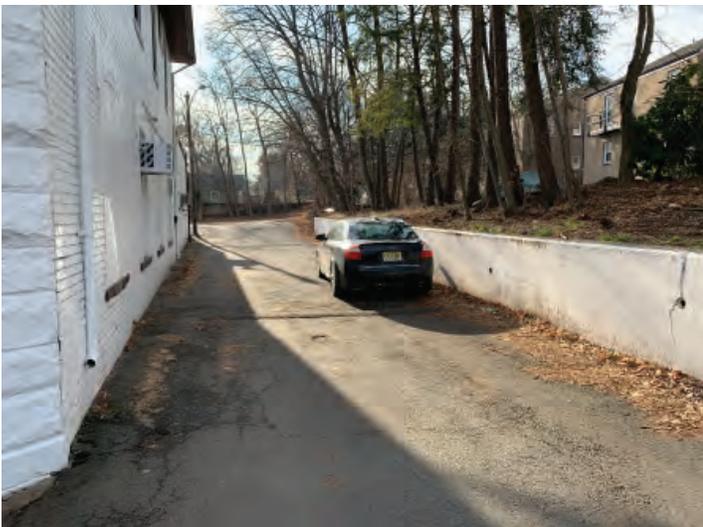
Figure 5: Side of building including 20-foot wide driveway with vehicle parked, no site lighting and no pedestrian walkway.

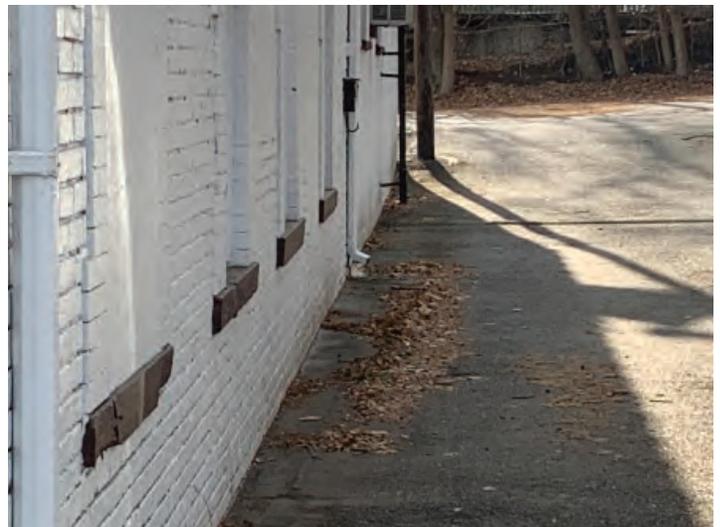
Figure 6: Downspout opening onto driveway.

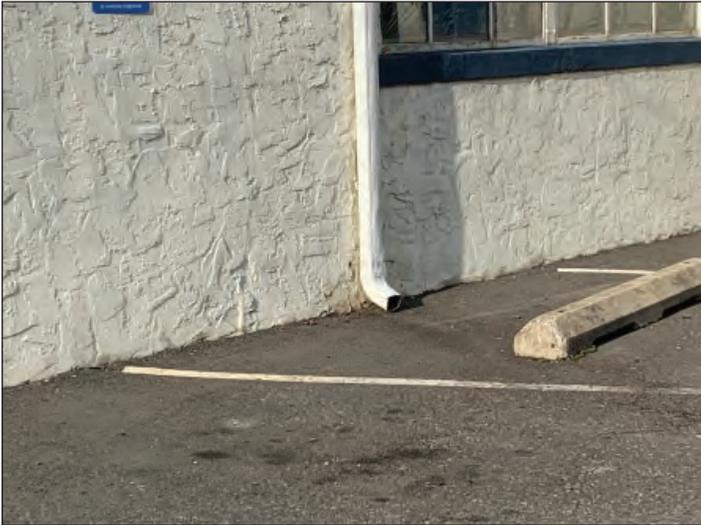
Figure 3: Downspout opening onto parking area.

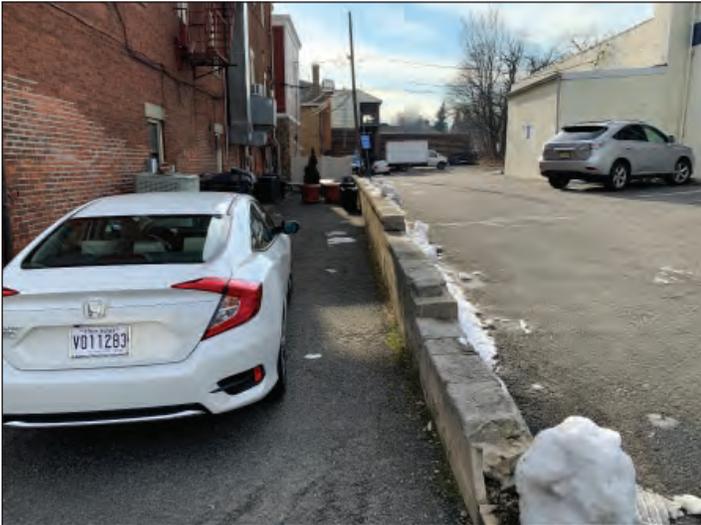
Figure 5: Retaining wall between driveways (Lot 24 to the left, Lot 23 to the right), without safety barrier.

With the exception of site lighting and the addition of a barrier above the retaining wall between Lots 24, 25, and 23, the conditions affecting this site cannot be easily corrected. The width of the parking area on Lot 25 (30 feet) cannot accommodate a 24-foot wide two-way driveway and parking spaces in compliance with the standards at §600-6.A(1) (a) and (b). The driveway on the north side of Lot 24 cannot be reconfigured so that vehicles do not back out onto the sidewalk. Additionally, making the entrances accessible to mobility-impaired persons would require significant changes to the interior layouts of the building in order to ensure that there is enough maneuvering space inside the stores and other facilities, and possibly require ramps or similar structures to project into the sidewalk causing tripping hazards to pedestrians.

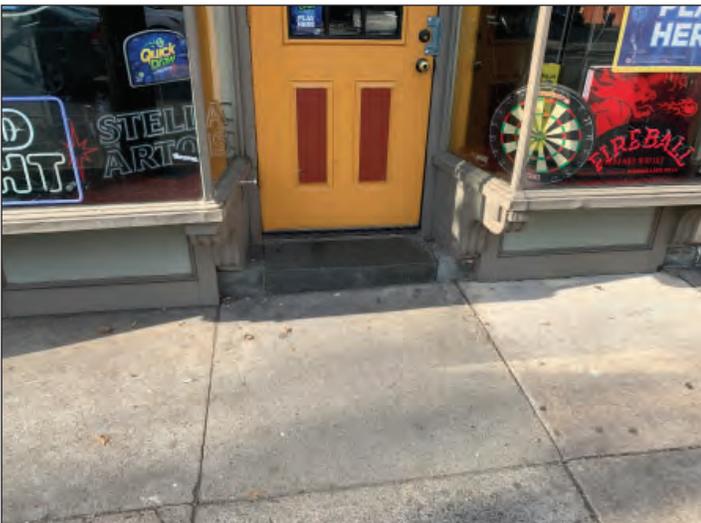
Figure 3: Non-ADA accessible entrance between two bay windows.

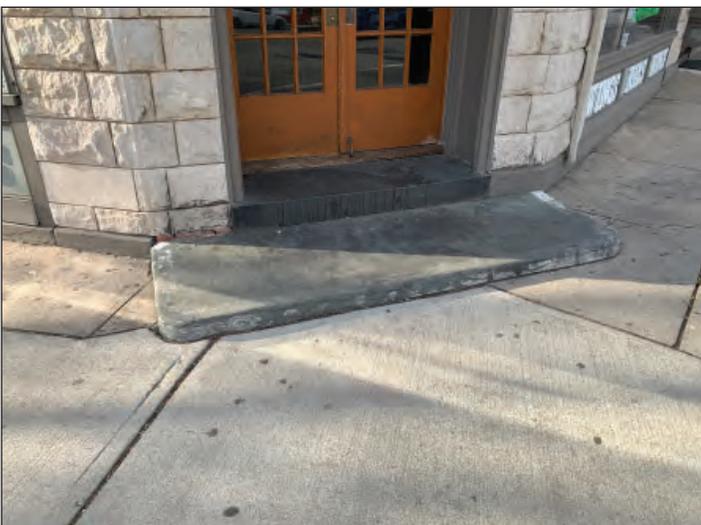
Figure 5: Non-ADA accessible entrance.

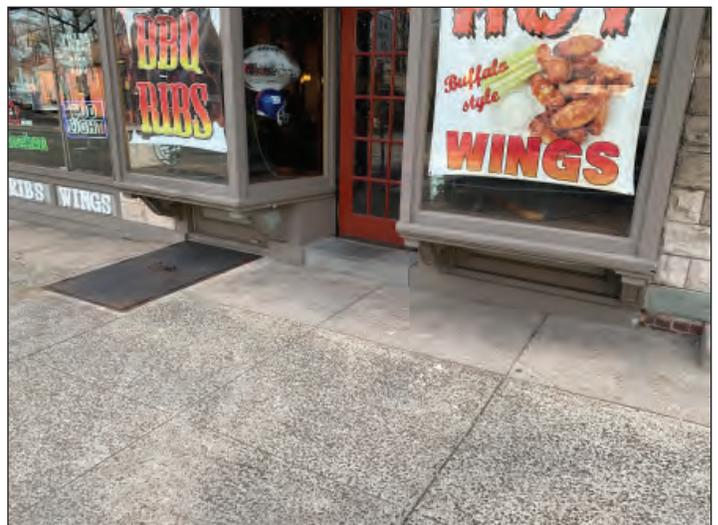
Figure 6: Non-ADA accessible entrance, between bay windows that project into pedestrian walking path.

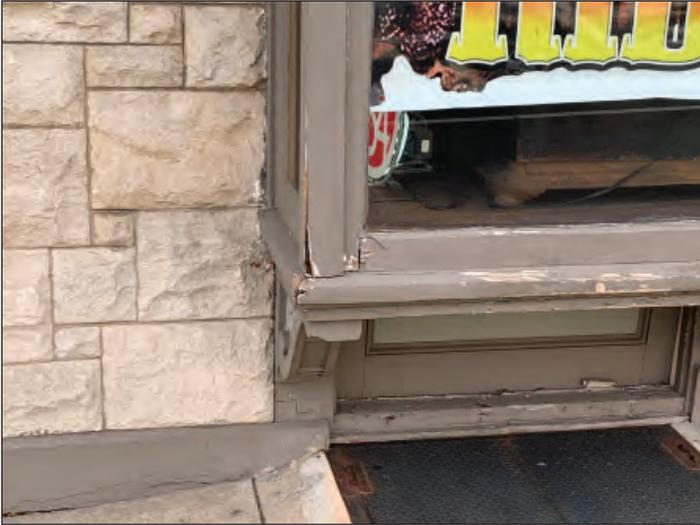
Figure 7: Deteriorated wood bay-window frame.

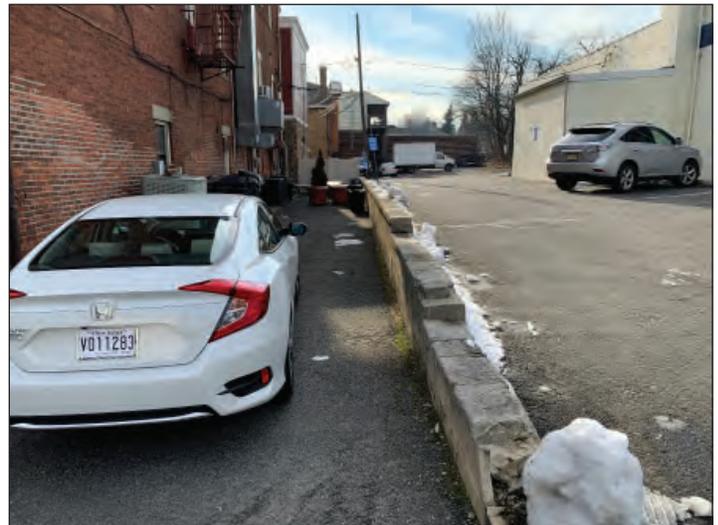
Figure 10: Retaining wall between driveways on Lot 23 (right) and Lot 24 (left), without safety barrier or site lighting.

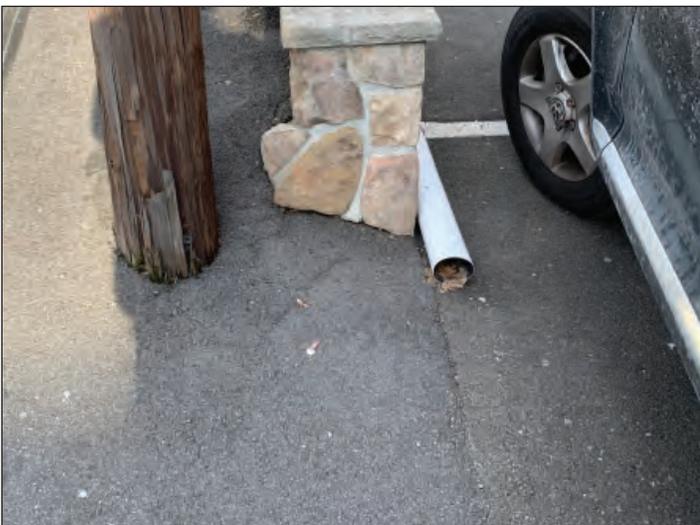
Figure 11: Stormwater outlet opening onto pavement in parking area.

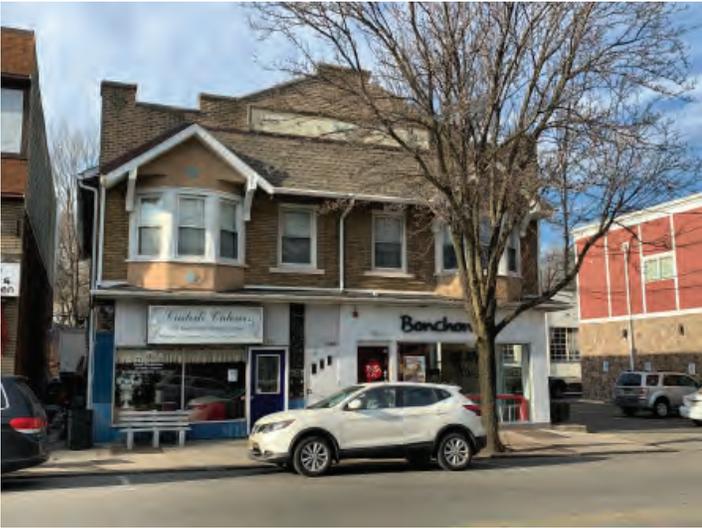
Figure 1: Front building facade of 551/553 Franklin Ave (Lot 26).

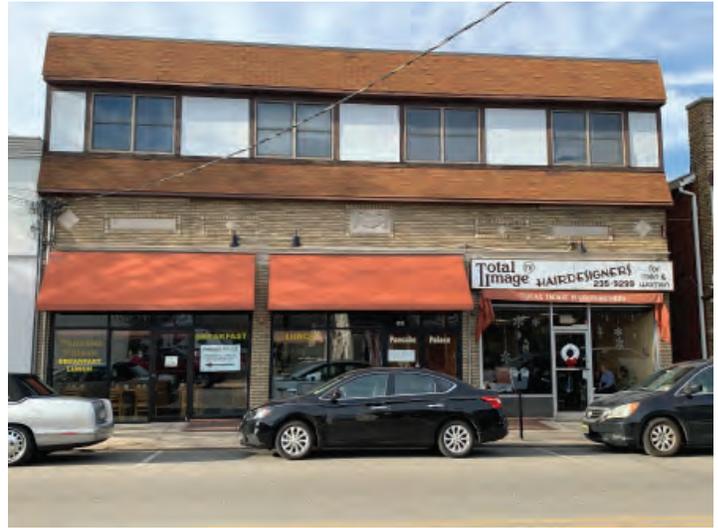
Figure 2: Front building facade of 545 Franklin Ave (Lot 27).

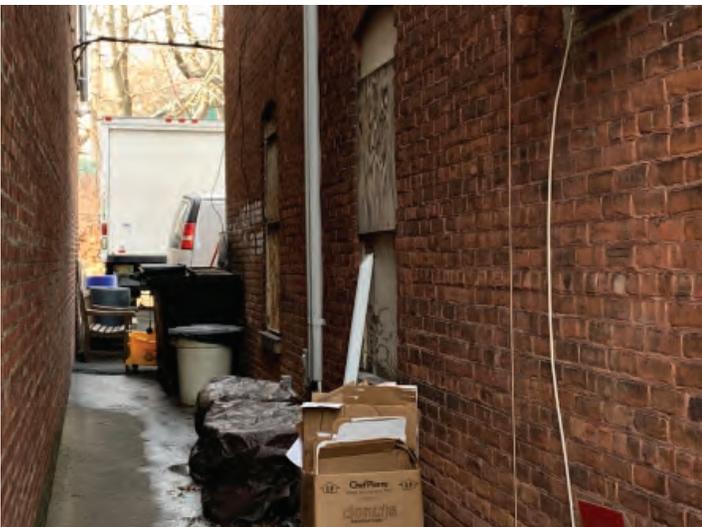
Figure 5: Boarded-up windows on 551 Franklin Avenue (Lot 26), in alley.

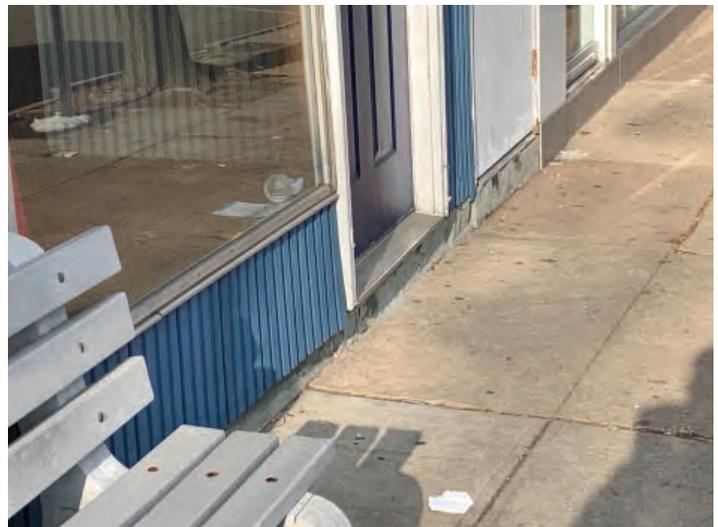
Figure 6: Non-accessible building entrance at 551 Franklin Avenue

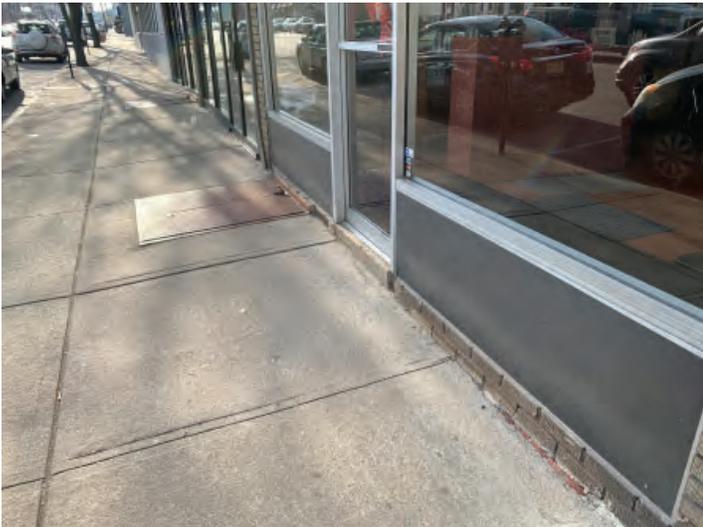
Figure 7: Front building facade, 545 Franklin Avenue.

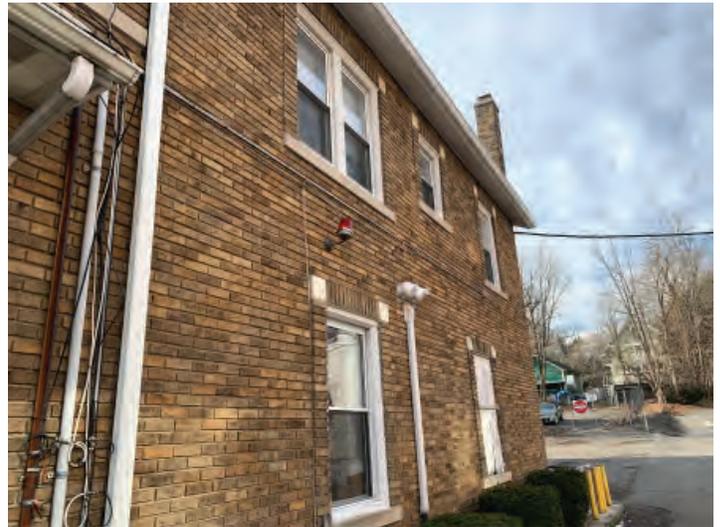
Figure 8: Apartment windows on north side of 551/553 Franklin Avenue (Lot 26).

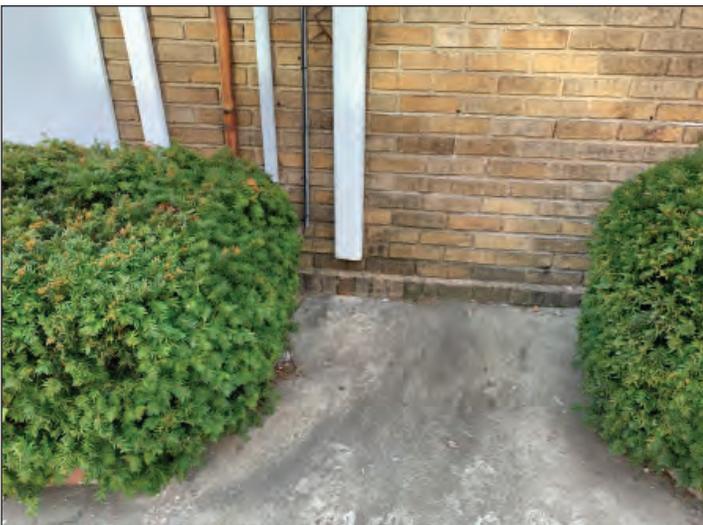
Figure 9: Downspout opening onto pavement on north side of 551/553 Franklin Avenue (Lot 26).

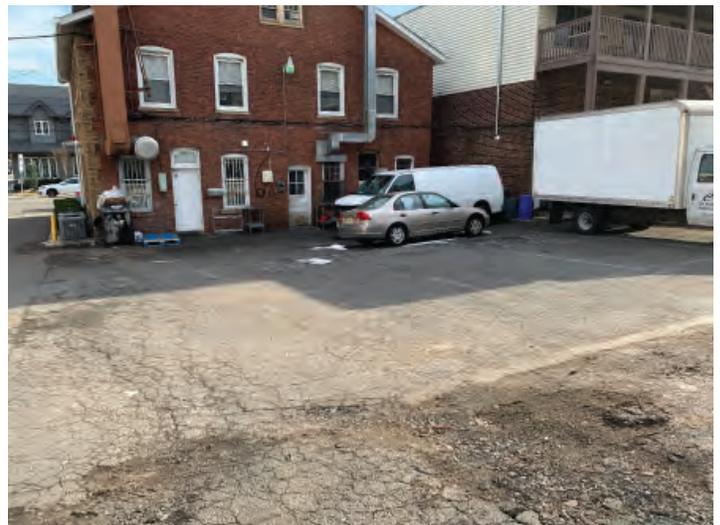
Figure 10: Rear parking and loading area on Lot 26.

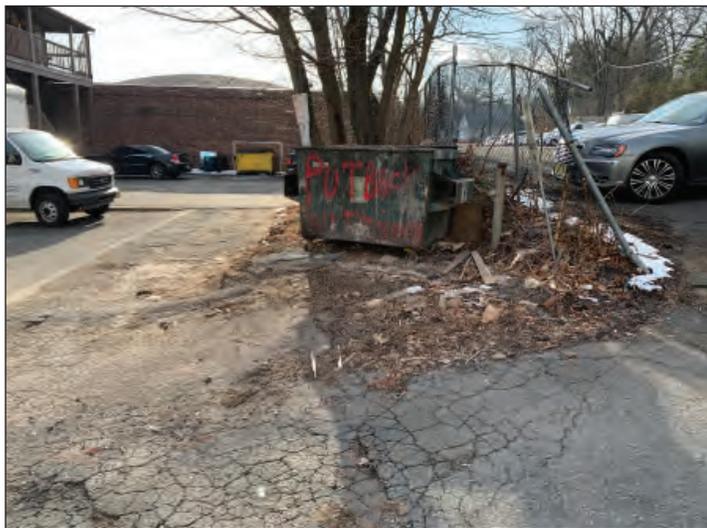
Figure 13: Dumpster for 551/553 Franklin Avenue (Lot 26) on boundary with Lot 28.

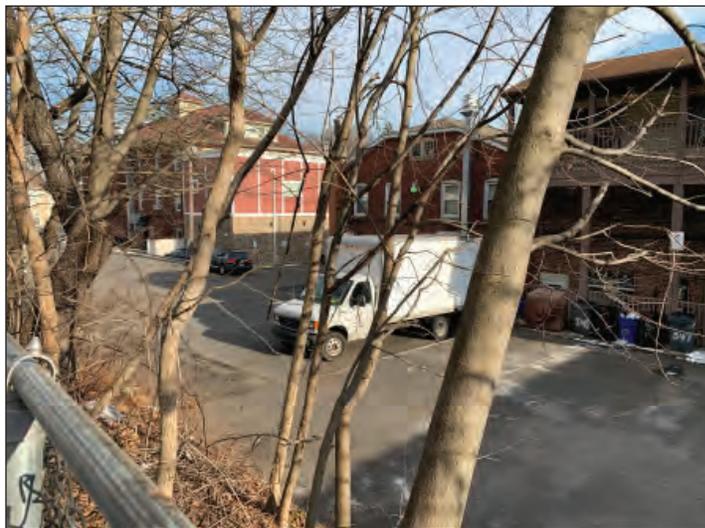
Figure 14: Parking/loading areas behind Lots 26 and 27, as seen from Lot 28.

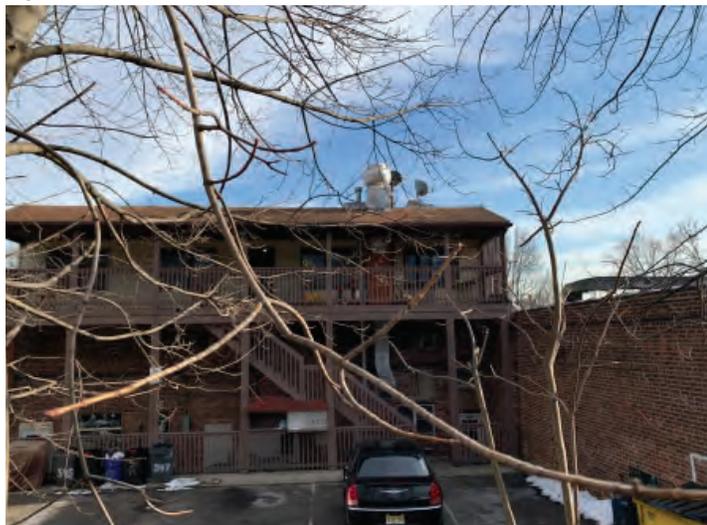
Figure 15: Rear of 545 Franklin Avenue (Lot 27), as seen from Lot 28.

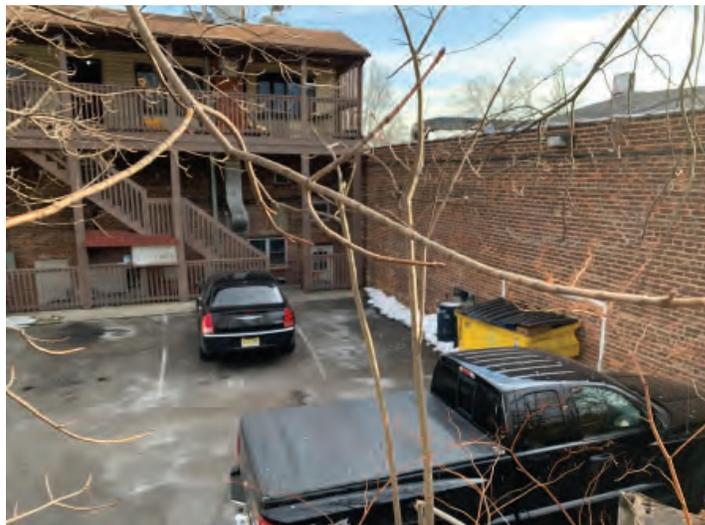
Figure 16: Parking area in back of Lot 27, including dumpster encroaching into maneuvering area for parking space (right).

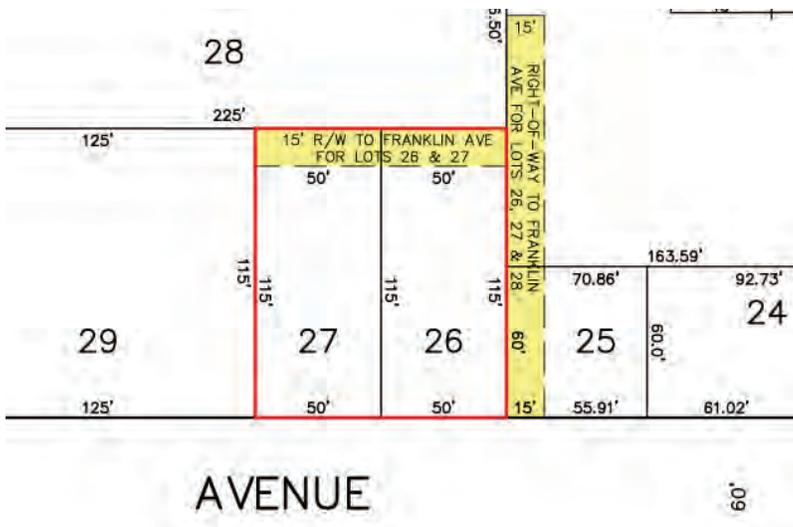
The two properties are adjacent lots occupied by two buildings separated by an alley approximately five (5) feet wide. Each building has ground floor commercial uses with residential apartments above. Both lots have rear parking and loading areas which rely on 15-foot wide right-of-way easement to access Franklin Avenue via the 15-foot wide two-way driveway on Lot 25 (See Figure 17).

Lots 23 and 25 by way of the 15 foot wide easements shown in Figure 17 in this section. This series of undersized and interconnected circulation aisles creates risks for collisions, vehicles being blocked from entering and exiting parking and loading areas (including emergency vehicles and garbage collection vehicles), and causes generally inefficient and dangerous maneuvering situations for vehicles circulating through the sites. Figure 16, for example, shows a dumpster located at the end of the access aisle in the rear parking area on Lot 27 partially blocking the maneuvering space needed to access an adjacent parking space. The rear parking areas also have very limited site lighting, which can increase risk of accidents by vehicles maneuvering in the parking areas or make the site attractive to criminal activity.

Figure 17: Image from tax map, showing right-of-way access easements.

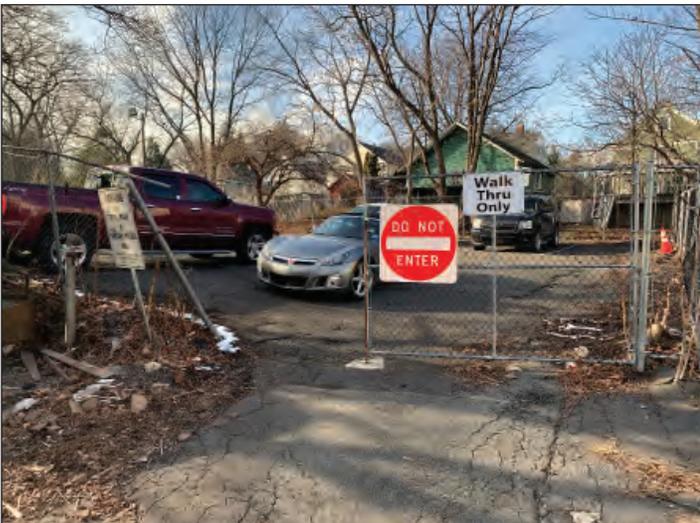
Figure 1: Gate prohibiting entry to parking on Lot 28 from Lot 23.

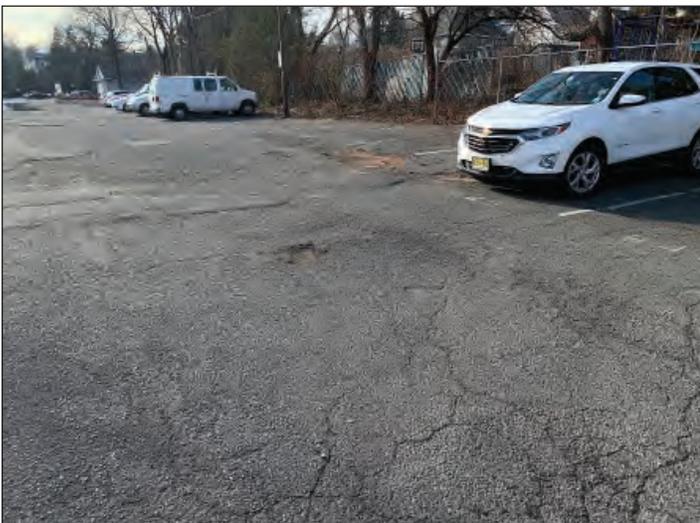
The pavement throughout Lots 28 and 30 is generally in deteriorated condition. As Figures 2 to 6 on the subsequent pages show, there are significant holes in the aisles and parking spaces which can create risks of personal injury and vehicular damage especially with the limited site lighting through portions of the parking lots.

Figure 3: Deteriorated pavement on Lot 28 including in access aisle and in parking spaces.

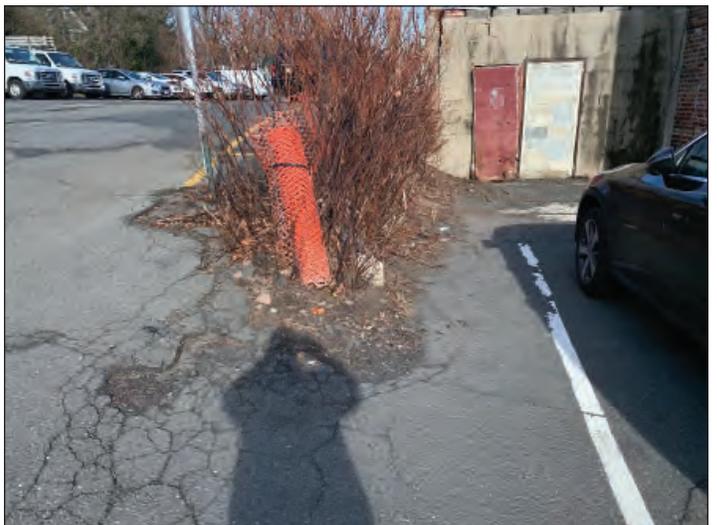
Figure 8: Grade change between Lot 28 and 29 without protective barrier.

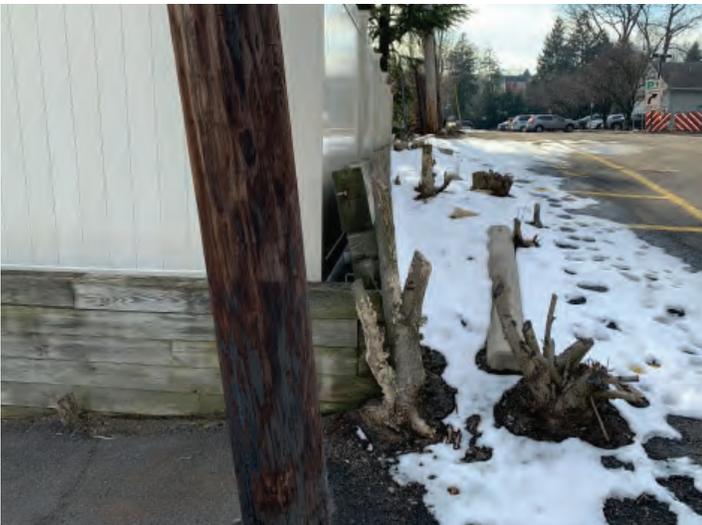
Figure 9: Unstable wooden wall along property line between Lots 30 and 31.

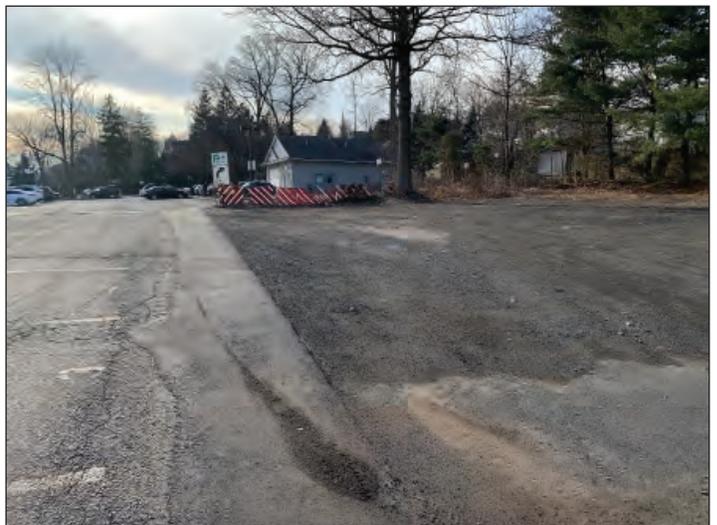
Lot 28 and the western-most section of Lot 30 are uphill from Lots 23, 26, 27, 29, 31, and 32 (in the Study Area) fronting on Franklin Avenue. Due to the grade changes between the lots, there are retaining walls along the line between Lot 30 and Lots 31 and 32 and a planted slope along the lot line between Lot 28 and Lots 26 and 27. During a site inspection, DMR observed that the retaining wall at the back of Lot 31 was leaning, indicating possible failure of the structure (See Figure 10).

Figure 10: Uneven parking and circulation surfaces at southwest corner of Lot 30.

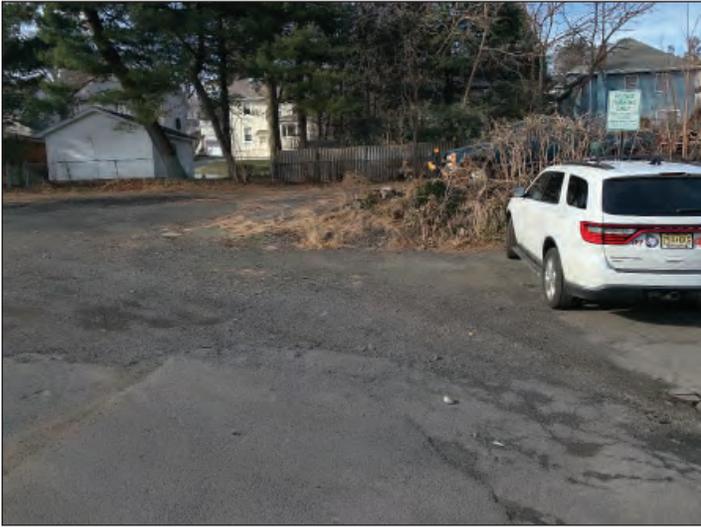
Figure 11: Grade change between parking / circulation areas on Lot 30 without barrier or striping.

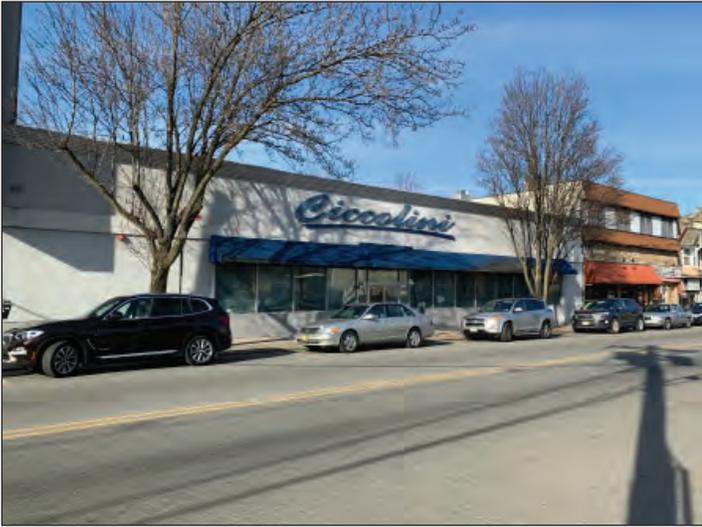
Figure 1: Existing storefront from Franklin Avenue.

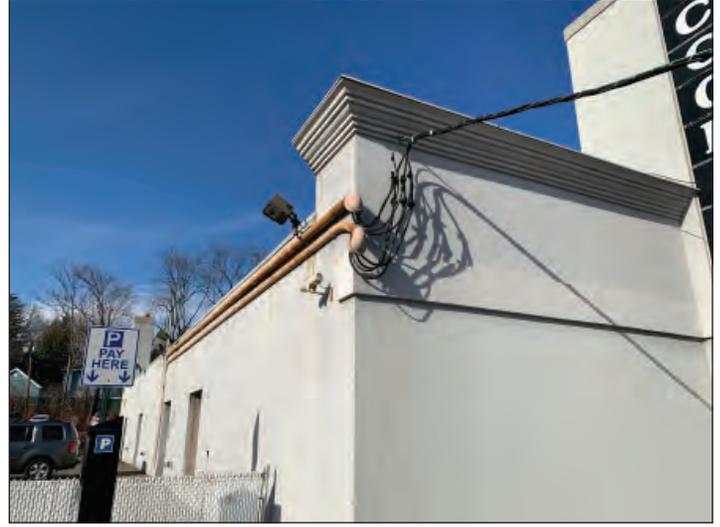
Figure 2: Electrical connection to building from street.

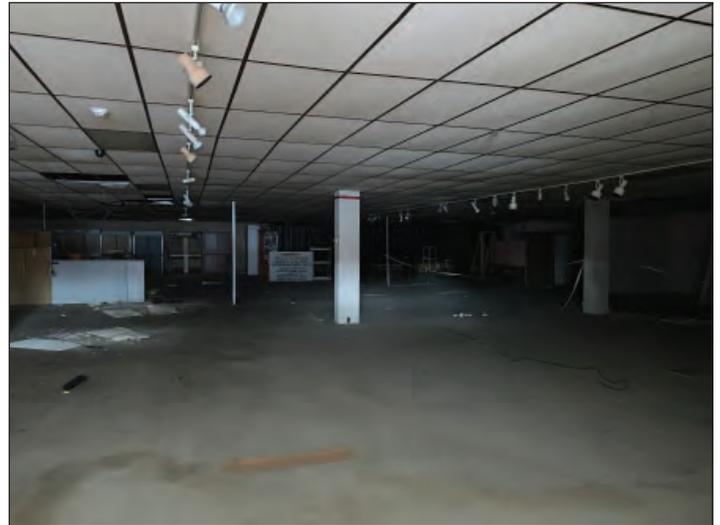
Figure 4: Vacant showroom.

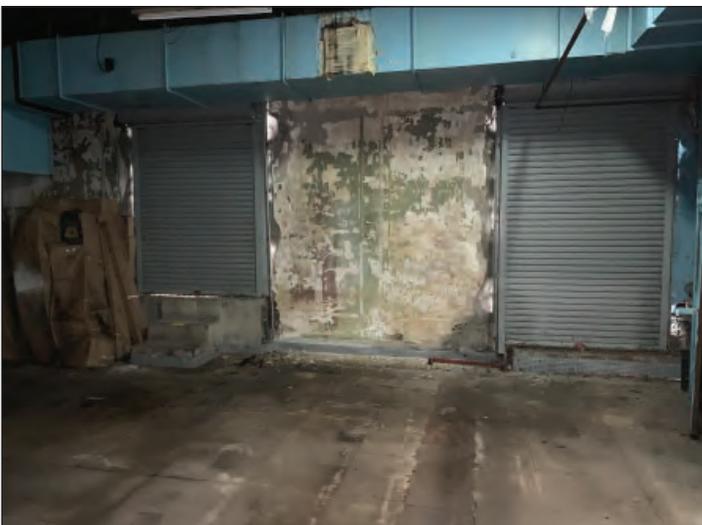
Figure 11: Crumbling wall around loading doors, letting light and water into building.

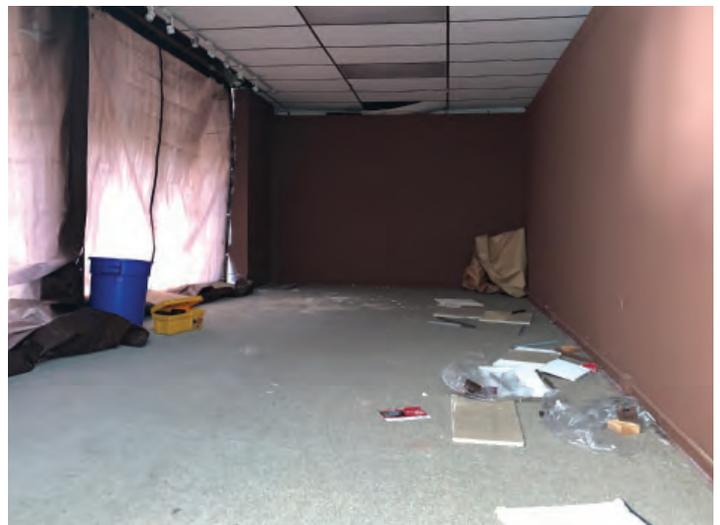
Figure 12: Vacant interior area with garbage accumulating.

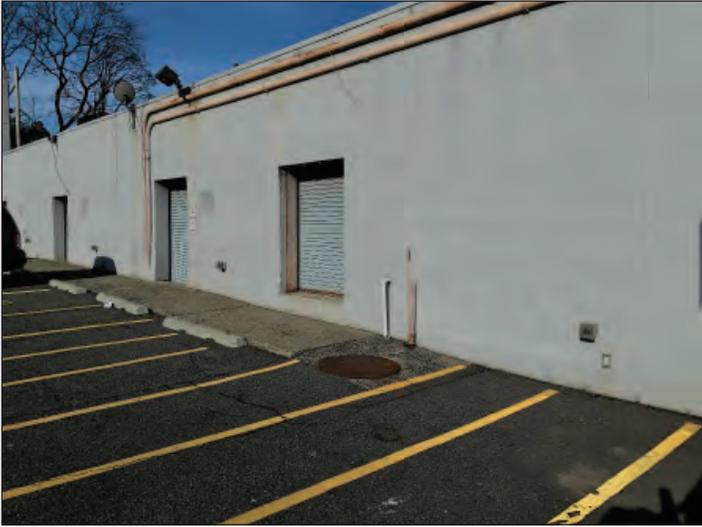
Figure 13: Exterior wall of loading on Lot 30. .

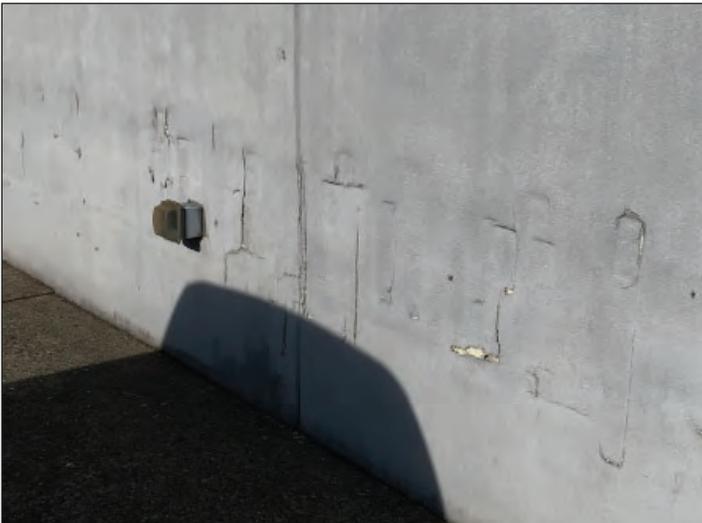
Figure 15: Wall damage near loading area on Lot 30..

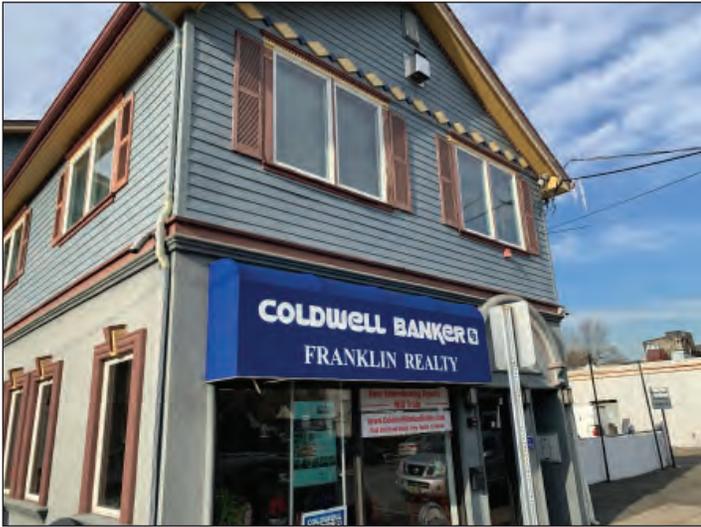
Figure 1: Front building facade.

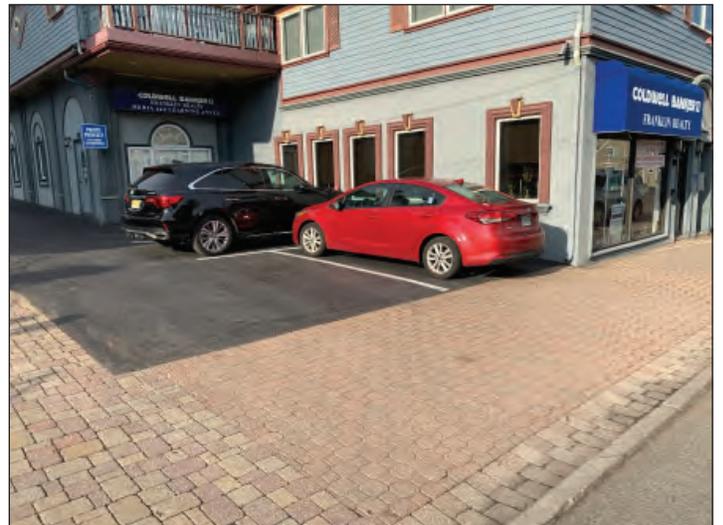
Figure 4: Nonconforming parking space requiring back-out maneuvering onto sidewalk.

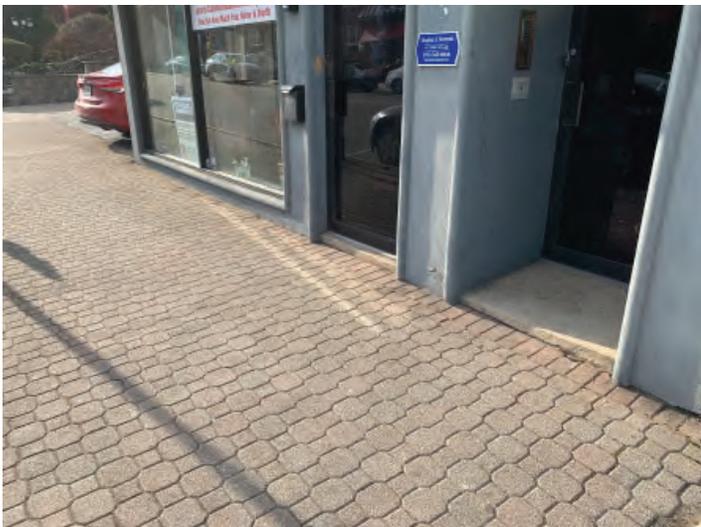
Figure 5: Non-wheelchair accessible building entrances.

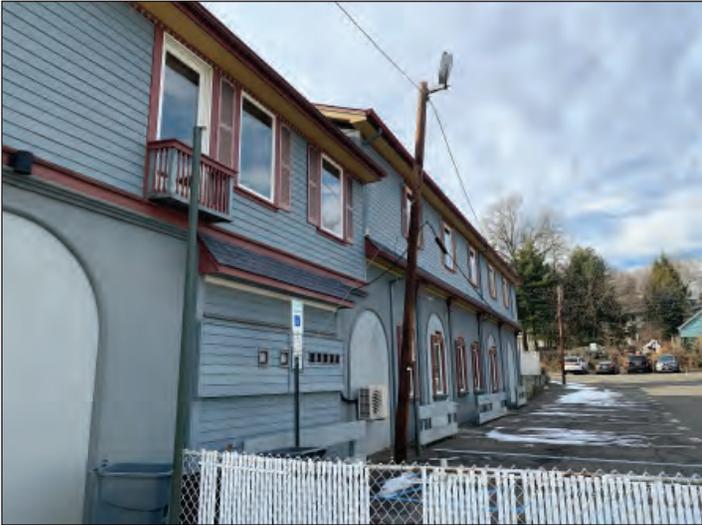
Figure 7: Apartments on second story overlooking Lot 30.

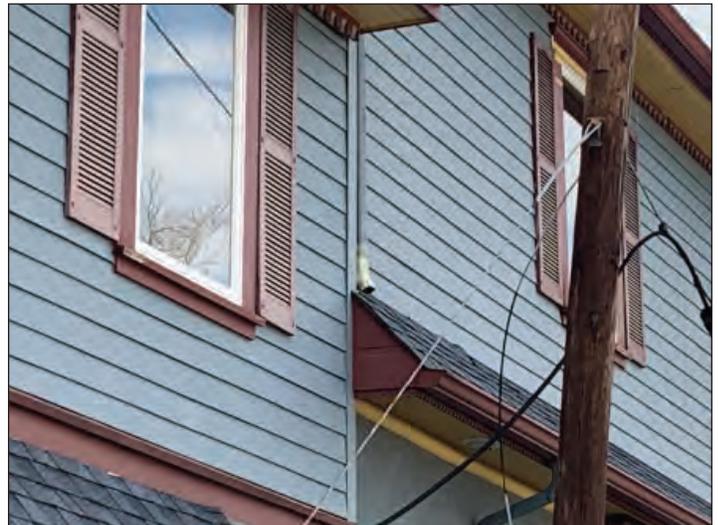
Figure 8: Downspout onto eaves overhanging Lot 30.

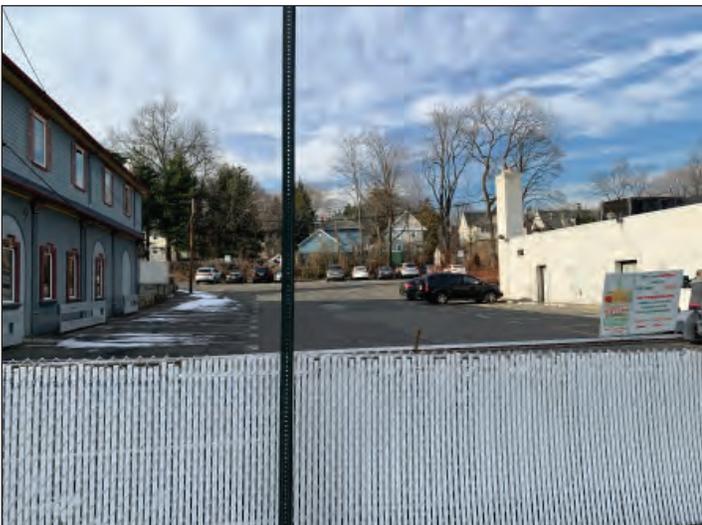
Figure 9: Driveway and parking area on Lot 30.

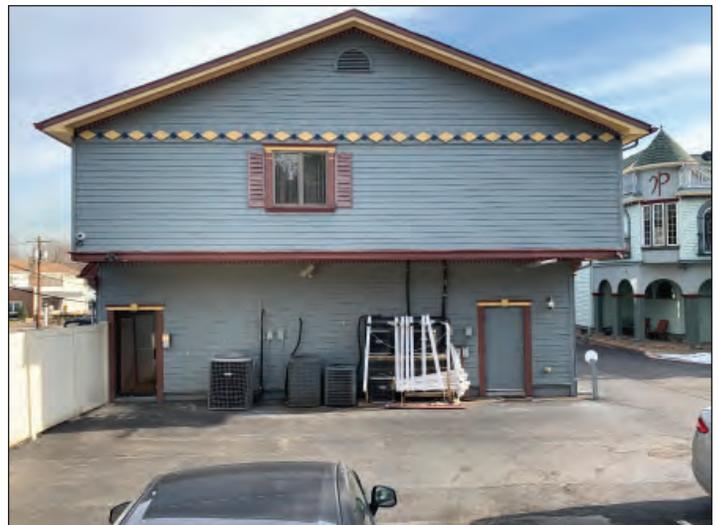
Figure 10: Rear of building, from Lot 30.

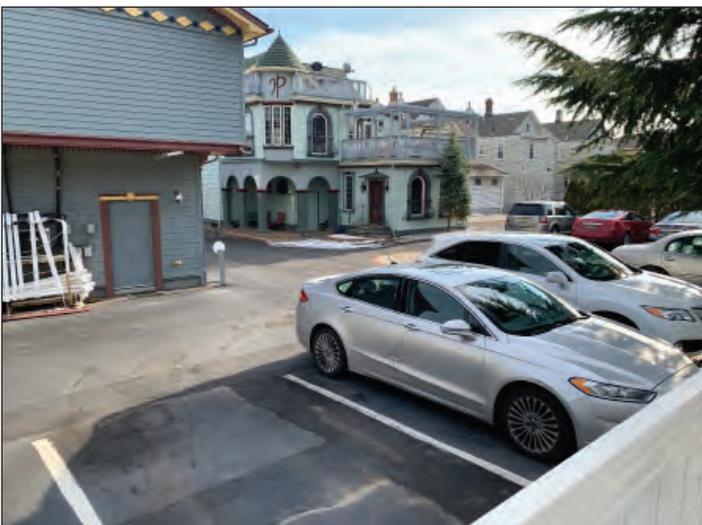
Figure 11: Parking at rear of Lot 31, from Lot 30. Building and parking areas of Lot 32 in top right quadrant of photo.

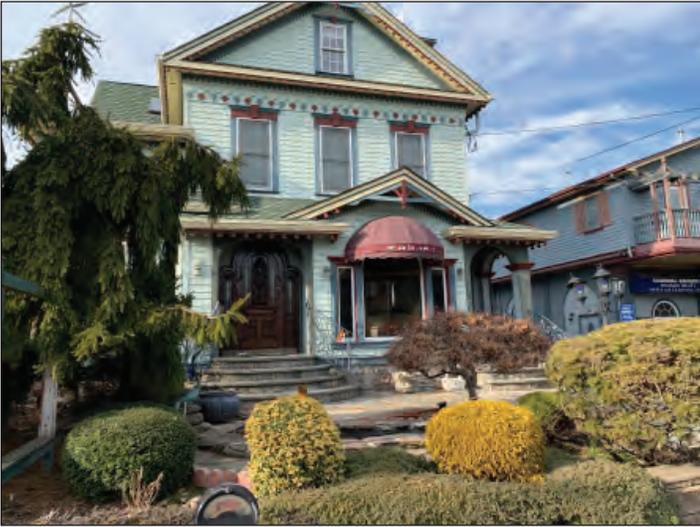
Figure 1: Front of building from Franklin Avenue.

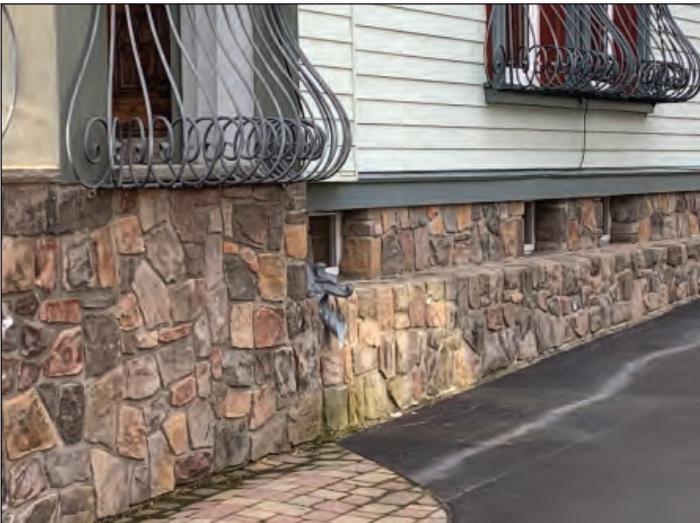
Despite having multiple landscaping areas to which to direct stormwater runoff, there are two (2) ornate downspouts opening onto the shared driveway. There is visible staining on the driveway beneath the downspouts and continuing toward the front of the house from years of stormwater being released from these downspouts, as well as moss growing in cracks and gaps between pavers on the driveway or stones on the side of the building. In addition there are no pedestrian sidewalks from the rear of the building along the access drive to protect pedestrians at night. This condition is exacerbated by the less than required dimension of the drive aisle and the lack of adequate site light, all of which represents a faulty arrangement and design. There also appear to be gaps forming between stones at the base of the building, which raise concerns about water penetrating the building foundation.

Figure 3: Ornate downspouts opening onto driveway. Visible staining and moss accumulation in between paver and wall stones.

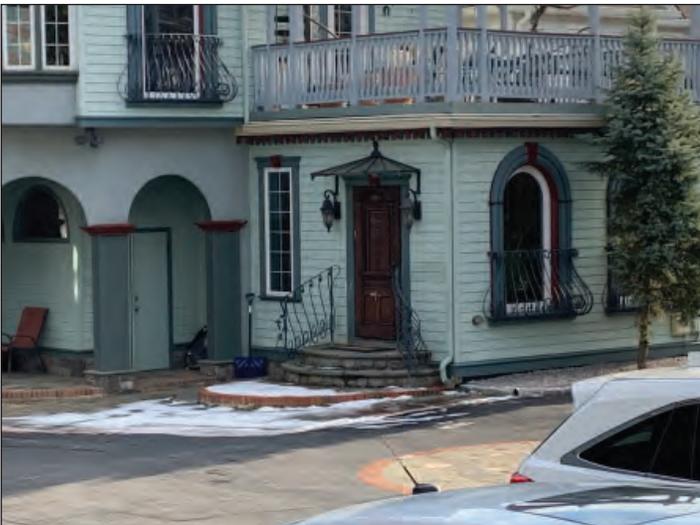
Figure 5: ADA non-accessible entrance at rear of building.

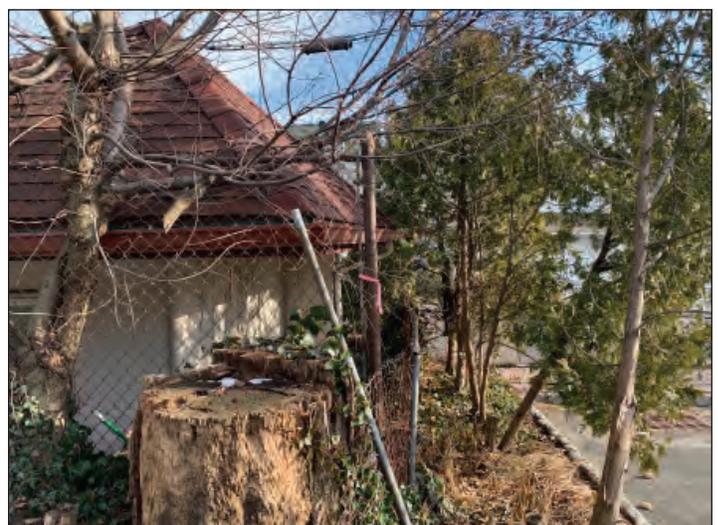
Figure 6: Rear accessory building near fence at boundary of Lots 32 and 37. Tree in top left quadrant of photo leaning on roof.

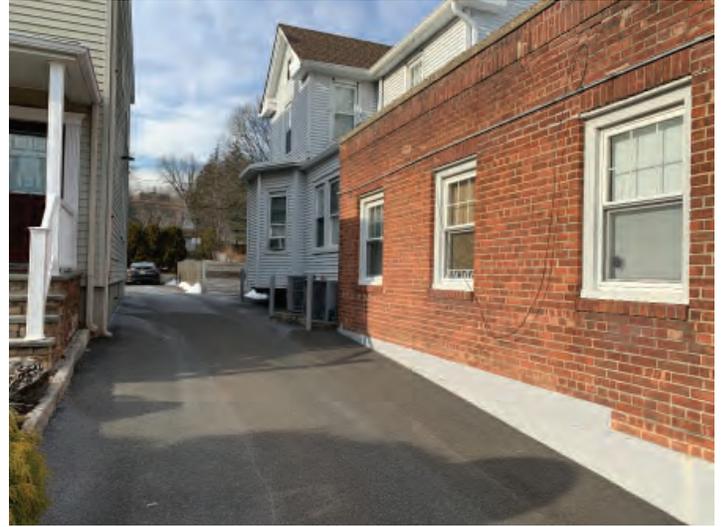
Figure 2: Side of building as viewed from driveway on Lot 34 (south).

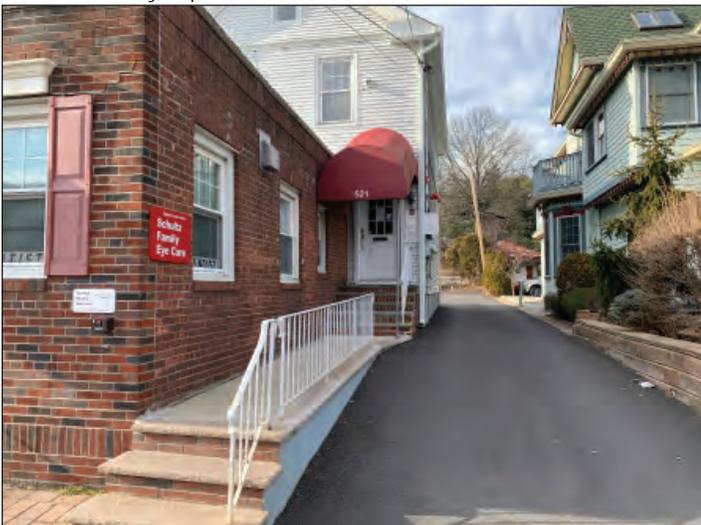
A 10-foot wide, two-way driveway provides access from Franklin Avenue to a five (5) space parking area in the rear of the property. The width of the driveway is not sufficient for two-way circulation, and creates unsafe conditions for vehicles and pedestrians on the property and within the public right of way in the event that two vehicles attempt to use the driveway at the same time. It may also be too narrow for

The 10-foot driveway to the rear parking area is inadequate for two-way circulation and creates unsafe conditions both on and off the property in the event that two vehicles attempt to access the driveway at the same time. The building is not accessible by mobility impaired persons due to the number of stairs. Additionally, the release of stormwater from downspouts onto the property without collection by an underground system or a strategically located planting area creates risks such as water and freeze-thaw damage to the buildings and paved areas on the property. This is further exacerbated when considering access from the rear parking to the main entrance would require pedestrians to maneuver along the 10 foot drive access at night and in cold weather. These are representative of obsolete conditions and a faulty arrange of design that are detrimental to public safety and welfare.

Figure 3: 10-foot wide two-way driveway on north side of lot.

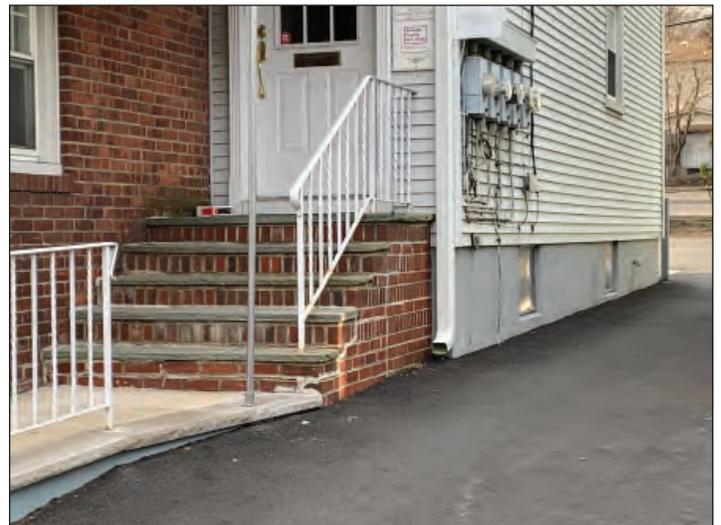
Figure 4: Entrance to rear building section. Not accessible to mobility impaired. Awning support pole obstructing path from driveway.

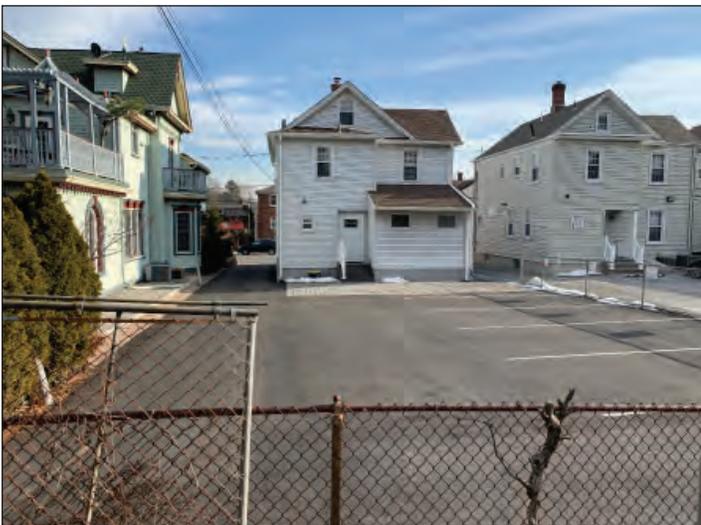
Figure 5: Parking area at rear of Lot 33, viewed from Lot 37. No ADA parking space.

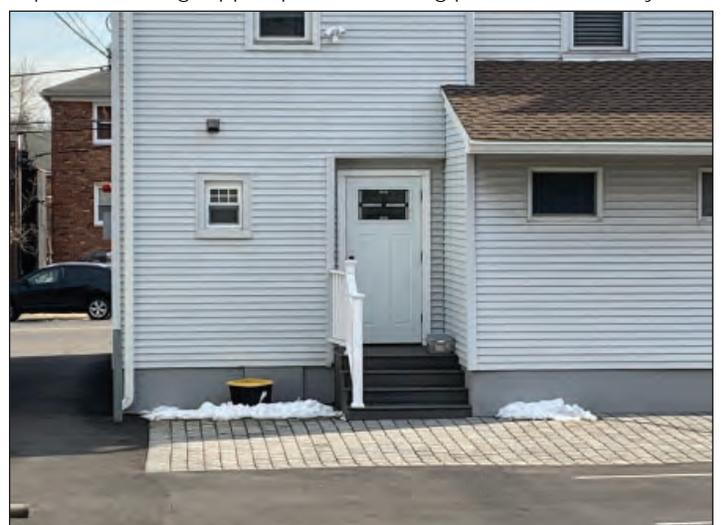
Figure 6: Rear entrance to building. Not accessible to mobility impaired.
