Report of

Preliminary Investigation for Determination of an Area in Need of Redevelopment

Block 3100 Lots 21, and 23 through 43

Prepared For:
Township of Nutley
Essex County, New Jersey
July 2020

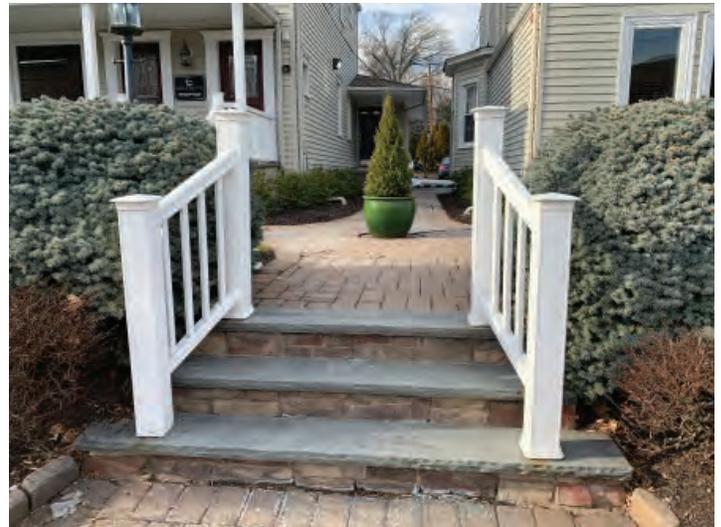
Figure 2: Stairs to common patio and walkway. Not accessible to mobility impaired.

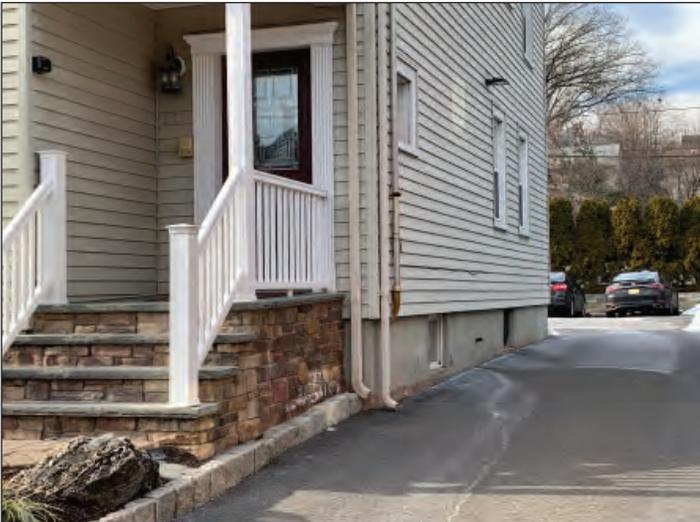
has the potential to be a public safety hazard. Access from the rear parking to the front entrance would be along the approximately 9 foot drive which represents a faulty arrangement and design that is detrimental to the health, safety and welfare of the public especially at night and in freezing conditions.

Figure 5: North side of 517 Franklin Avenue (left) with downspouts opening onto two-way driveway (right) with 9-feet of clearance.

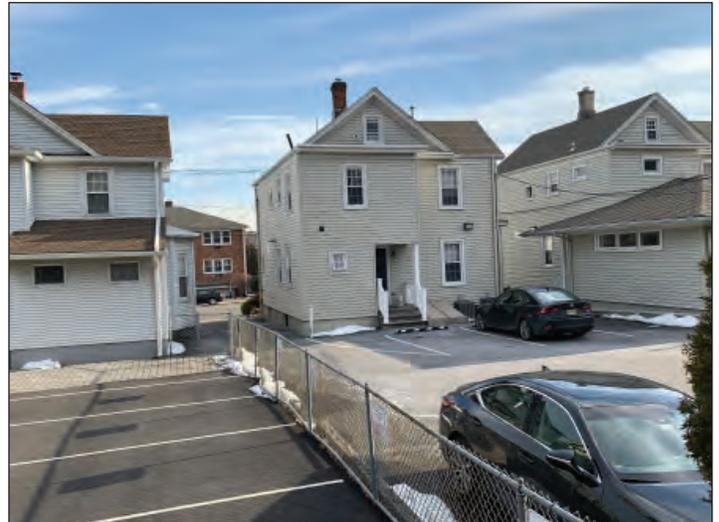
The rear parking area spans the rear yards of both lots and contains 11 parking spaces, none of which are dedicated handicap-accessible spaces. The spaces are approximately 16 feet deep whereas 19 feet is required. The parking area is accessed by a two-way driveway that is roughly 9 feet wide, which is too narrow for two vehicles to use at the same time or for use by emergency vehicles attempting to access the rear of the lot. DMR observed limited lighting for the parking area, which

Figure 6: Rear parking area behind 517 Franklin Avenue (Lot 34).

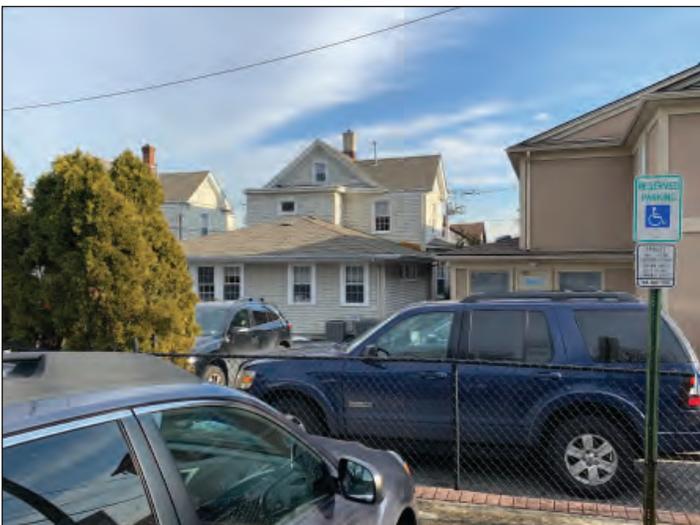
Figure 7: Rear parking area behind 513 Franklin Avenue (Lot 35), from Lot 37.

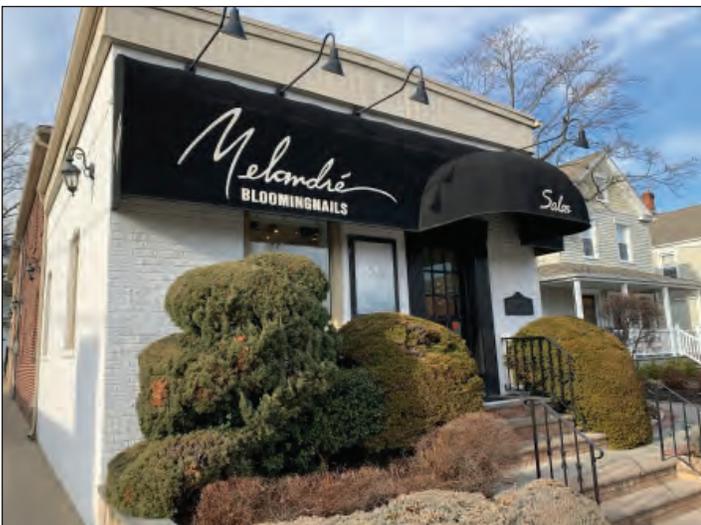
Figure 1: Front facade of building. Entrance not accessible to mobility impaired.

The dimensions of the site prohibit reconfiguration of the rear parking area. Due to the setback of the building entrance from the sidewalk, it is possible to construct an ADA-accessible building entrance at the expense of some of the landscaped area in the front yard.

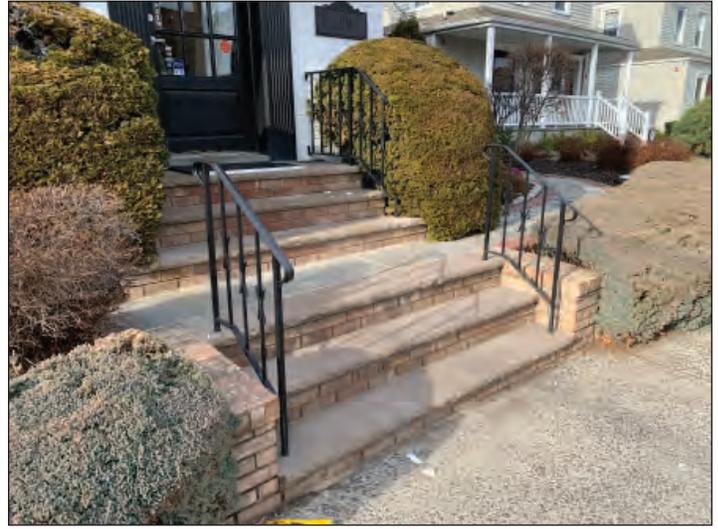
Figure 4: Stairs which are not accessible to disabled persons.

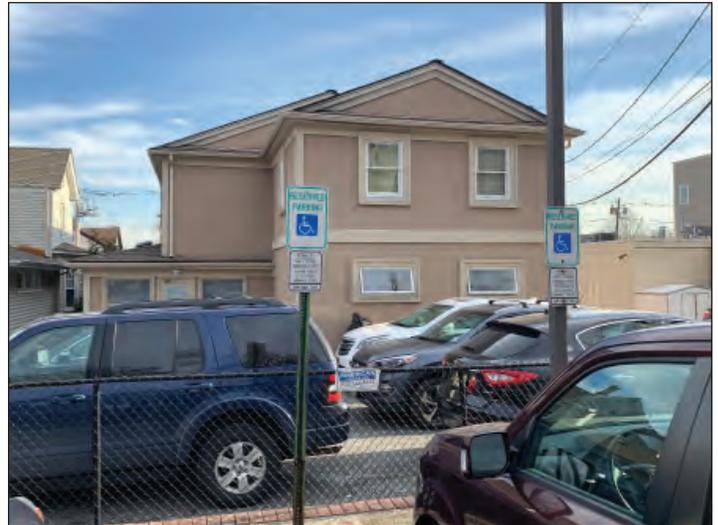
Figure 6: Parking area at rear of Lot 36, as viewed from Lot 37. Six (6) cars parked in tandem fashion.

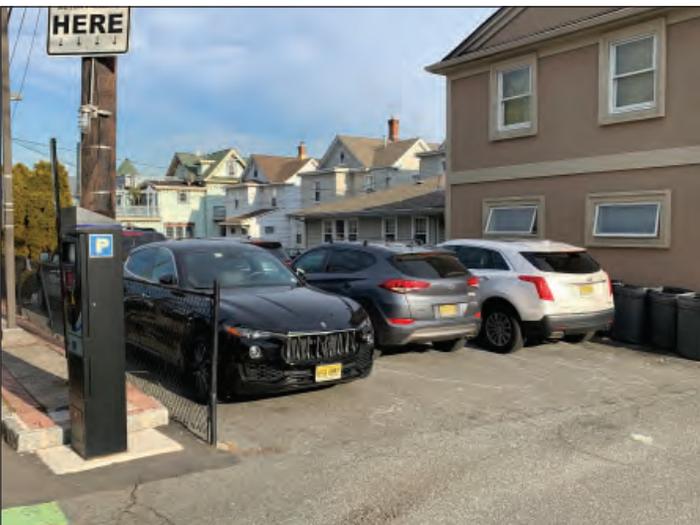
Figure 7: Parking area at rear of Lot 36, as viewed from Franklin Terrace. Six (6) cars parked in tandem fashion.

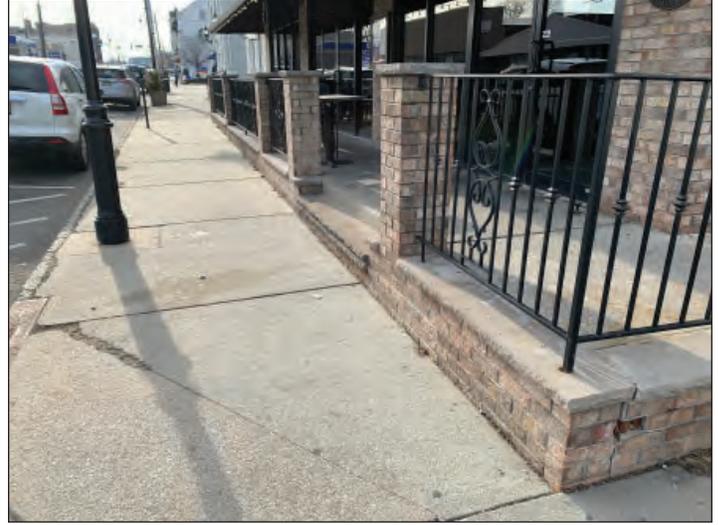
Figure 2: Patio for access to front entrance of restaurant. Not accessible to mobility impaired persons.

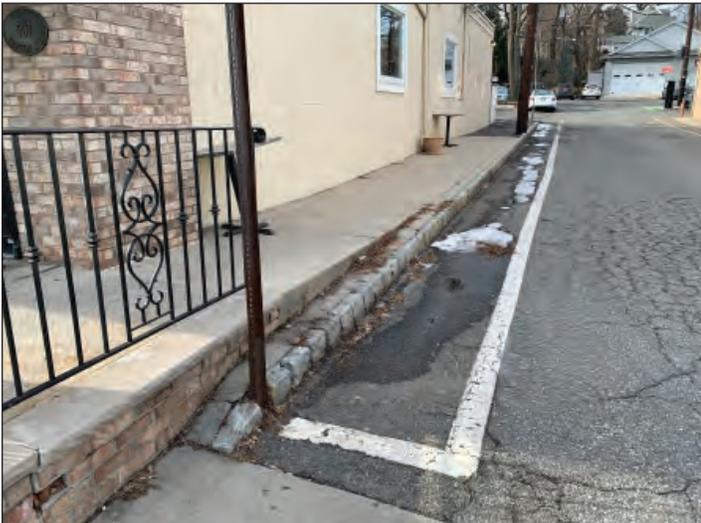
Figure 3: Tripping hazard caused by grade change between curb and driveway on Lot 37 (aka Franklin Terrace).

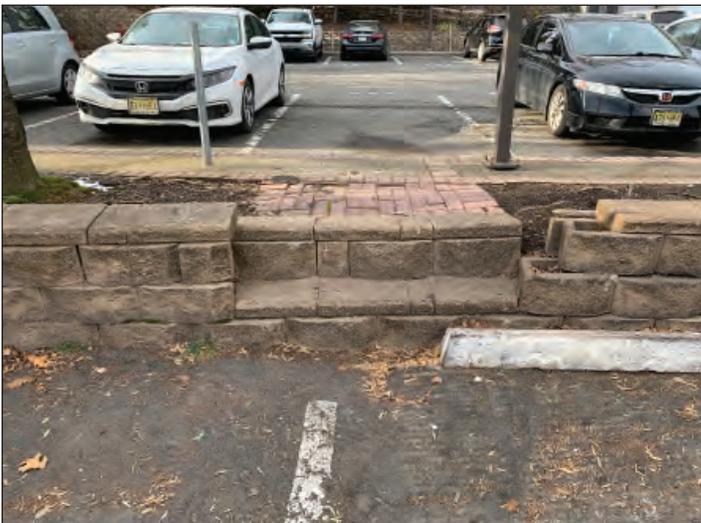
Figure 5: Uneven steps between rear parking area on Lot 38 and parking lot on Lot 39.

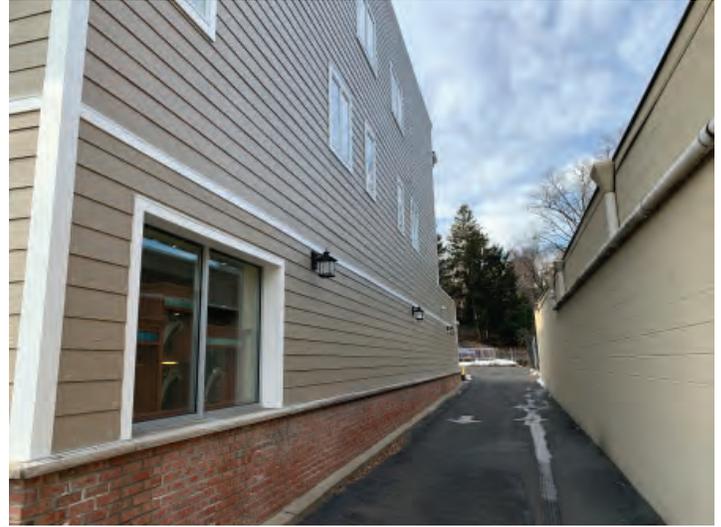
The 10-foot wide driveway is inadequate for two-way circulation or access by emergency vehicles, and creates unsafe conditions both on and off the property in the event that two vehicles attempt to access the driveway at the same time. The lack of lighting in the rear of the parking area exacerbates vehicular maneuvering and pedestrian safety hazards associated with the undersized facilities.

Figure 2: 10-foot wide two-way driveway at north side of lot.

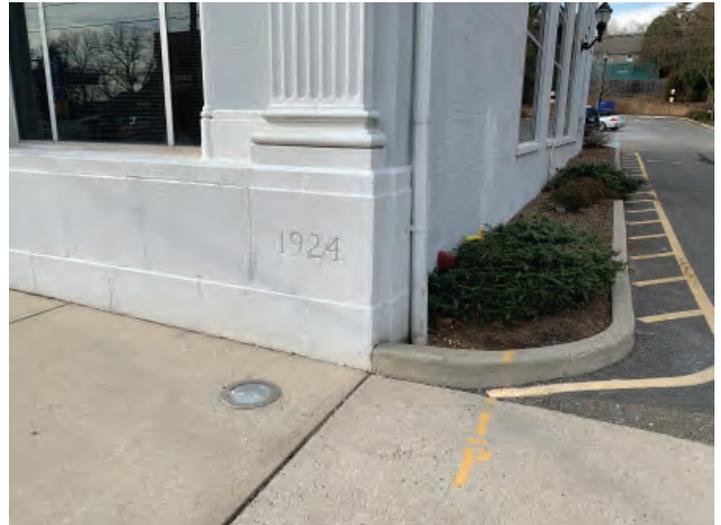
Figure 2: Downspout leading to impervious surface.

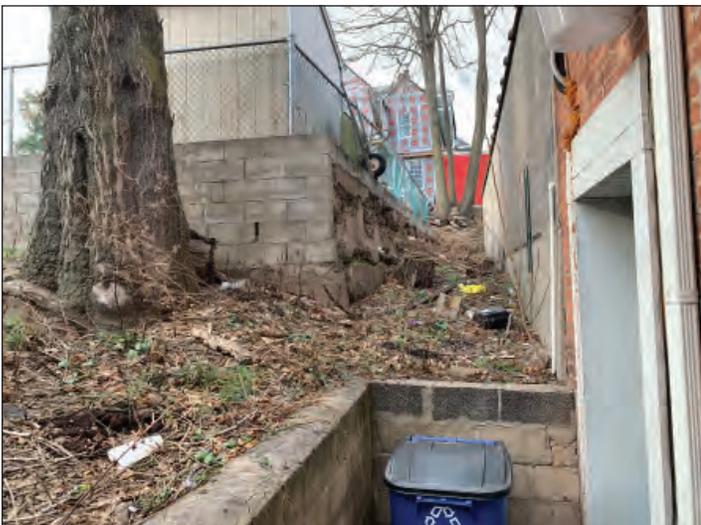
Figure 5: Crumbling retaining wall at rear Lot 43, adjacent to rear of building on Lot 41.

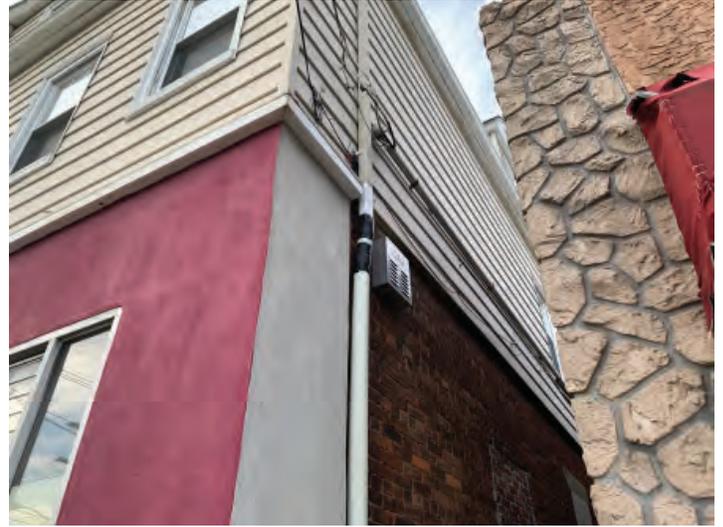
Figure 2: Connecting water pipes held together with tape.

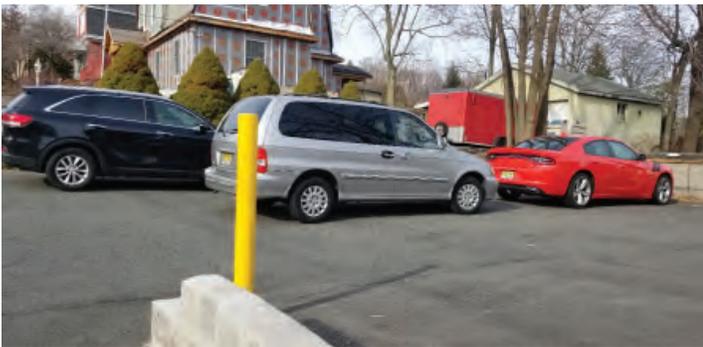
Figure 11: Cars parking in tandem fashion in rear parking area
